USPPRP Monitoring:
Results from 2003 and Plans for 2004

L.H. MacDonald, E. Brown, and Z. Libohova
Dept. of Forest, Rangeland, and Watershed Stewardship
Colorado State University

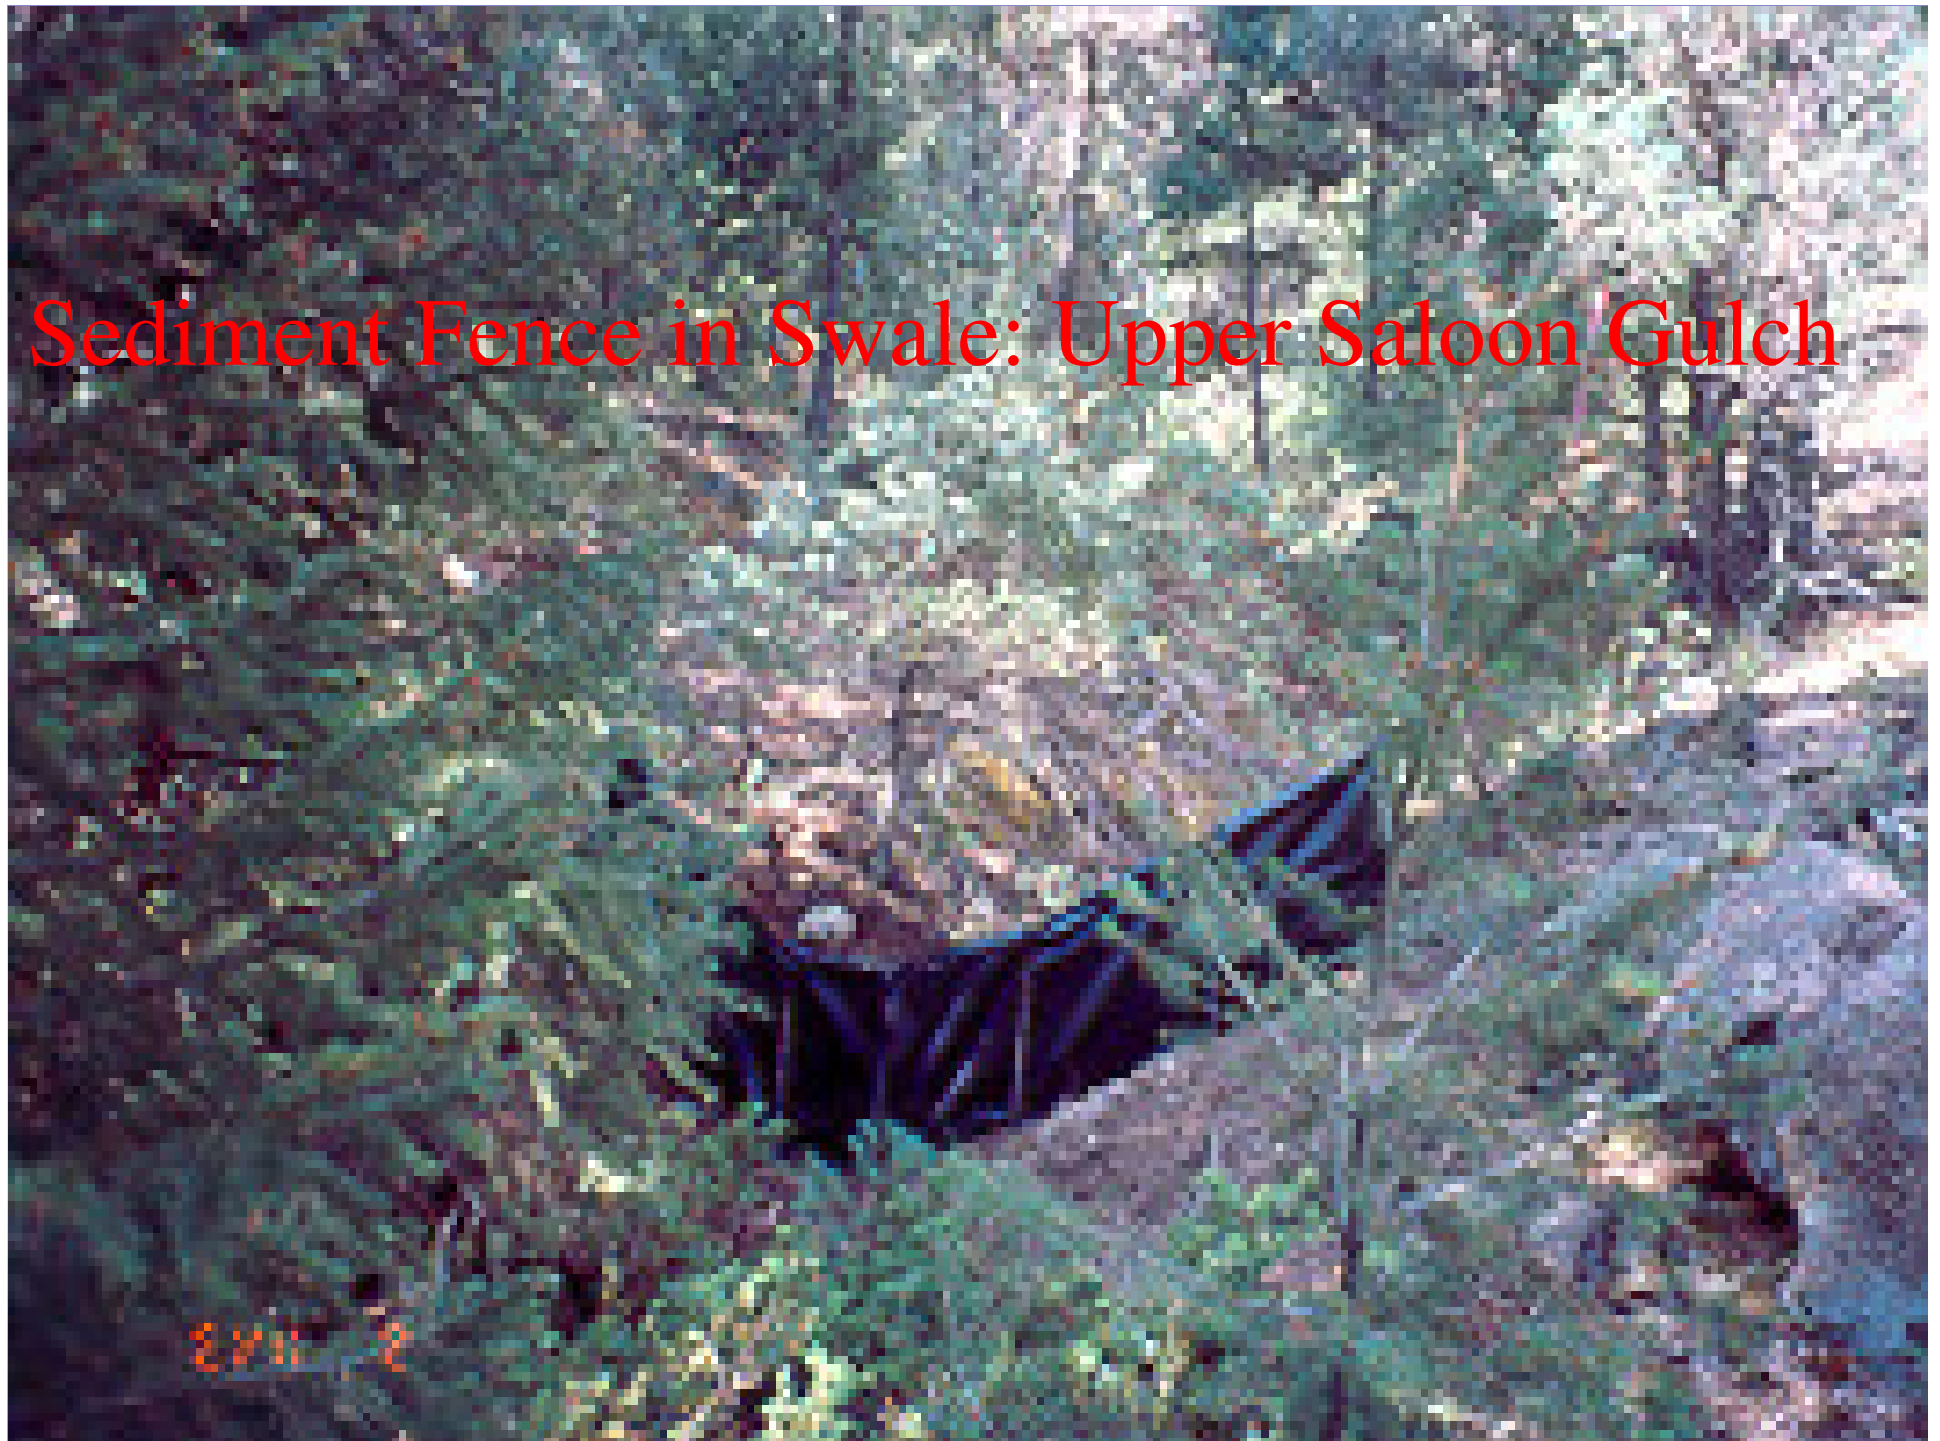
Sediment Fence in Swale: Upper Saloon Gulch

- Monitor sediment production from paired swales;
 - 11 pairs in Upper Saloon Gulch;
 - 8 pairs in Trumbull.
- Monitor sediment production from road segments;
 - 5 segments in Upper Saloon Gulch;
 - 8 segments in Spring Creek;
 - 3 segments in Trumbull.
- Measure key site characteristics (e.g., contributing area, slope, and percent cover);
- Six recording rain gauges.

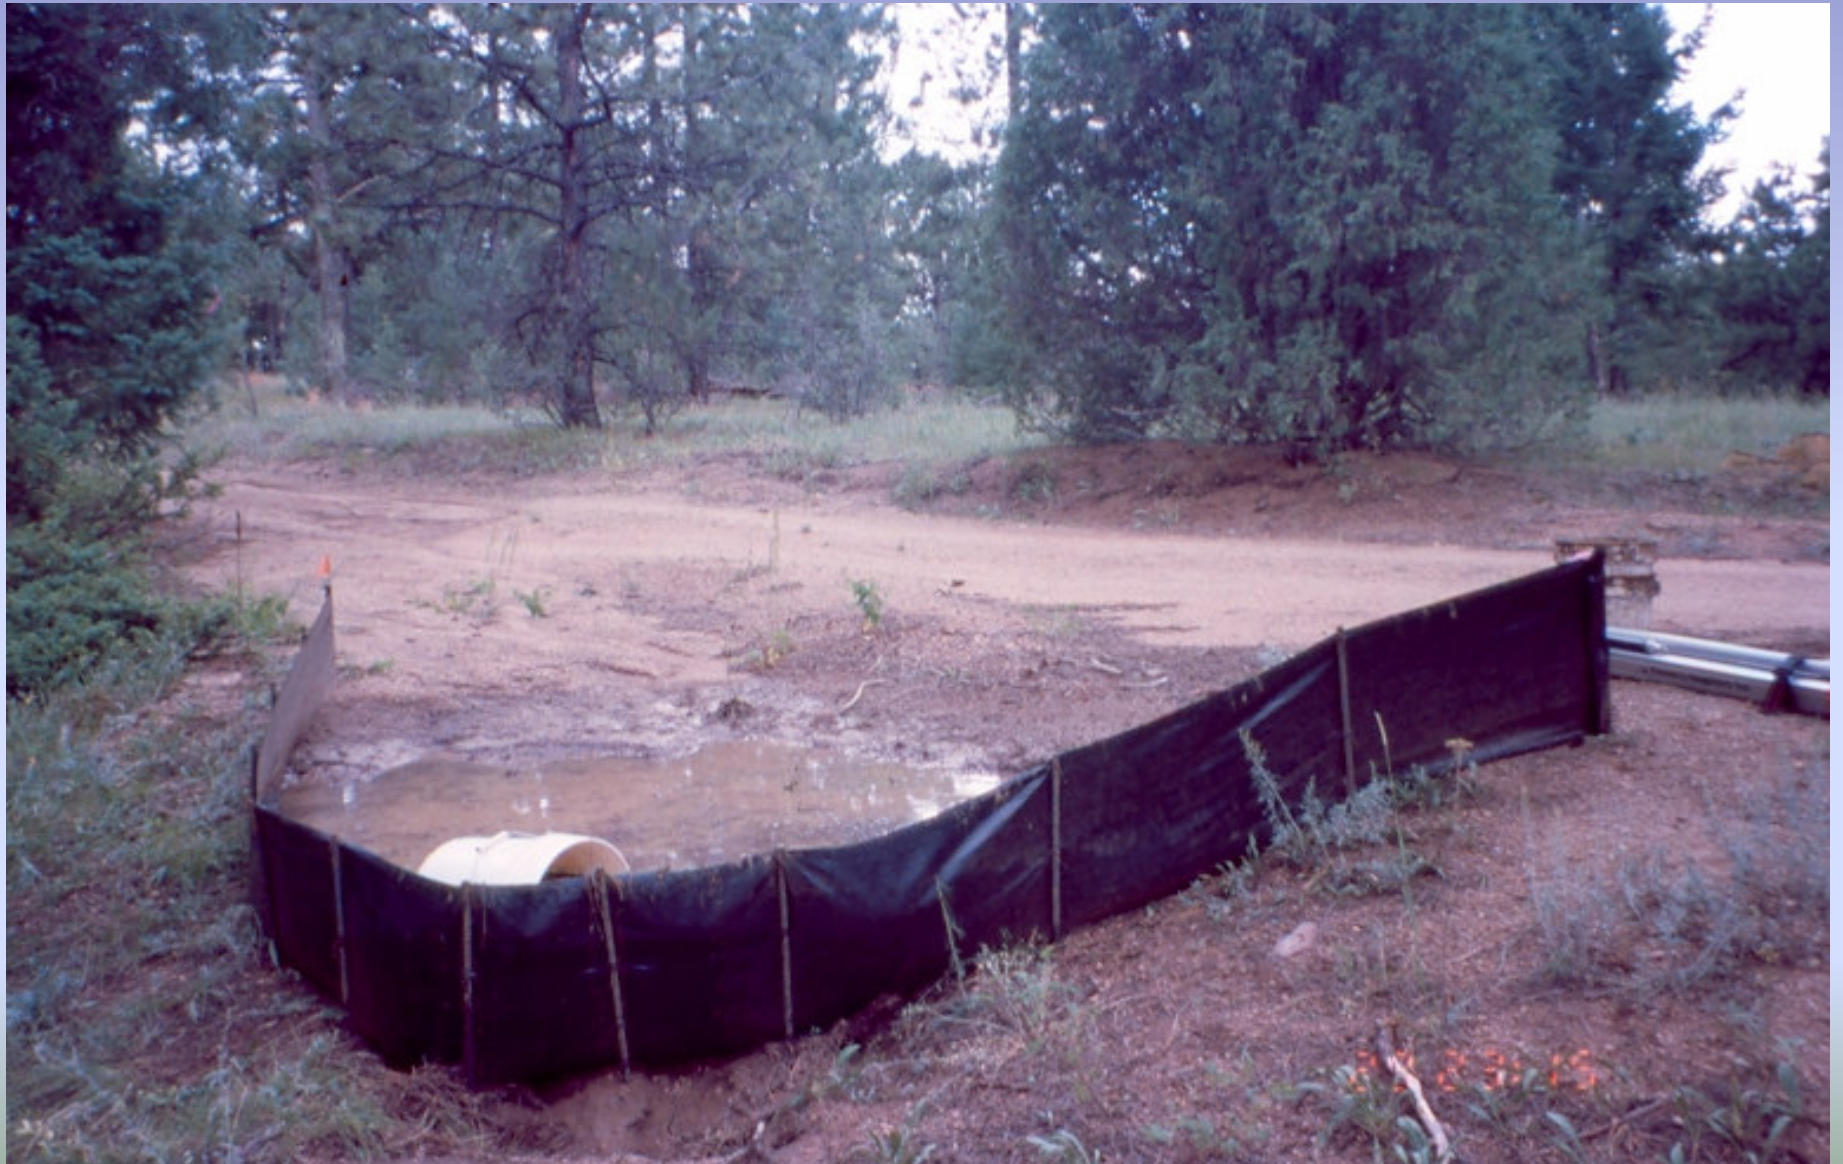
Sediment fence for a road segment: Spring Creek

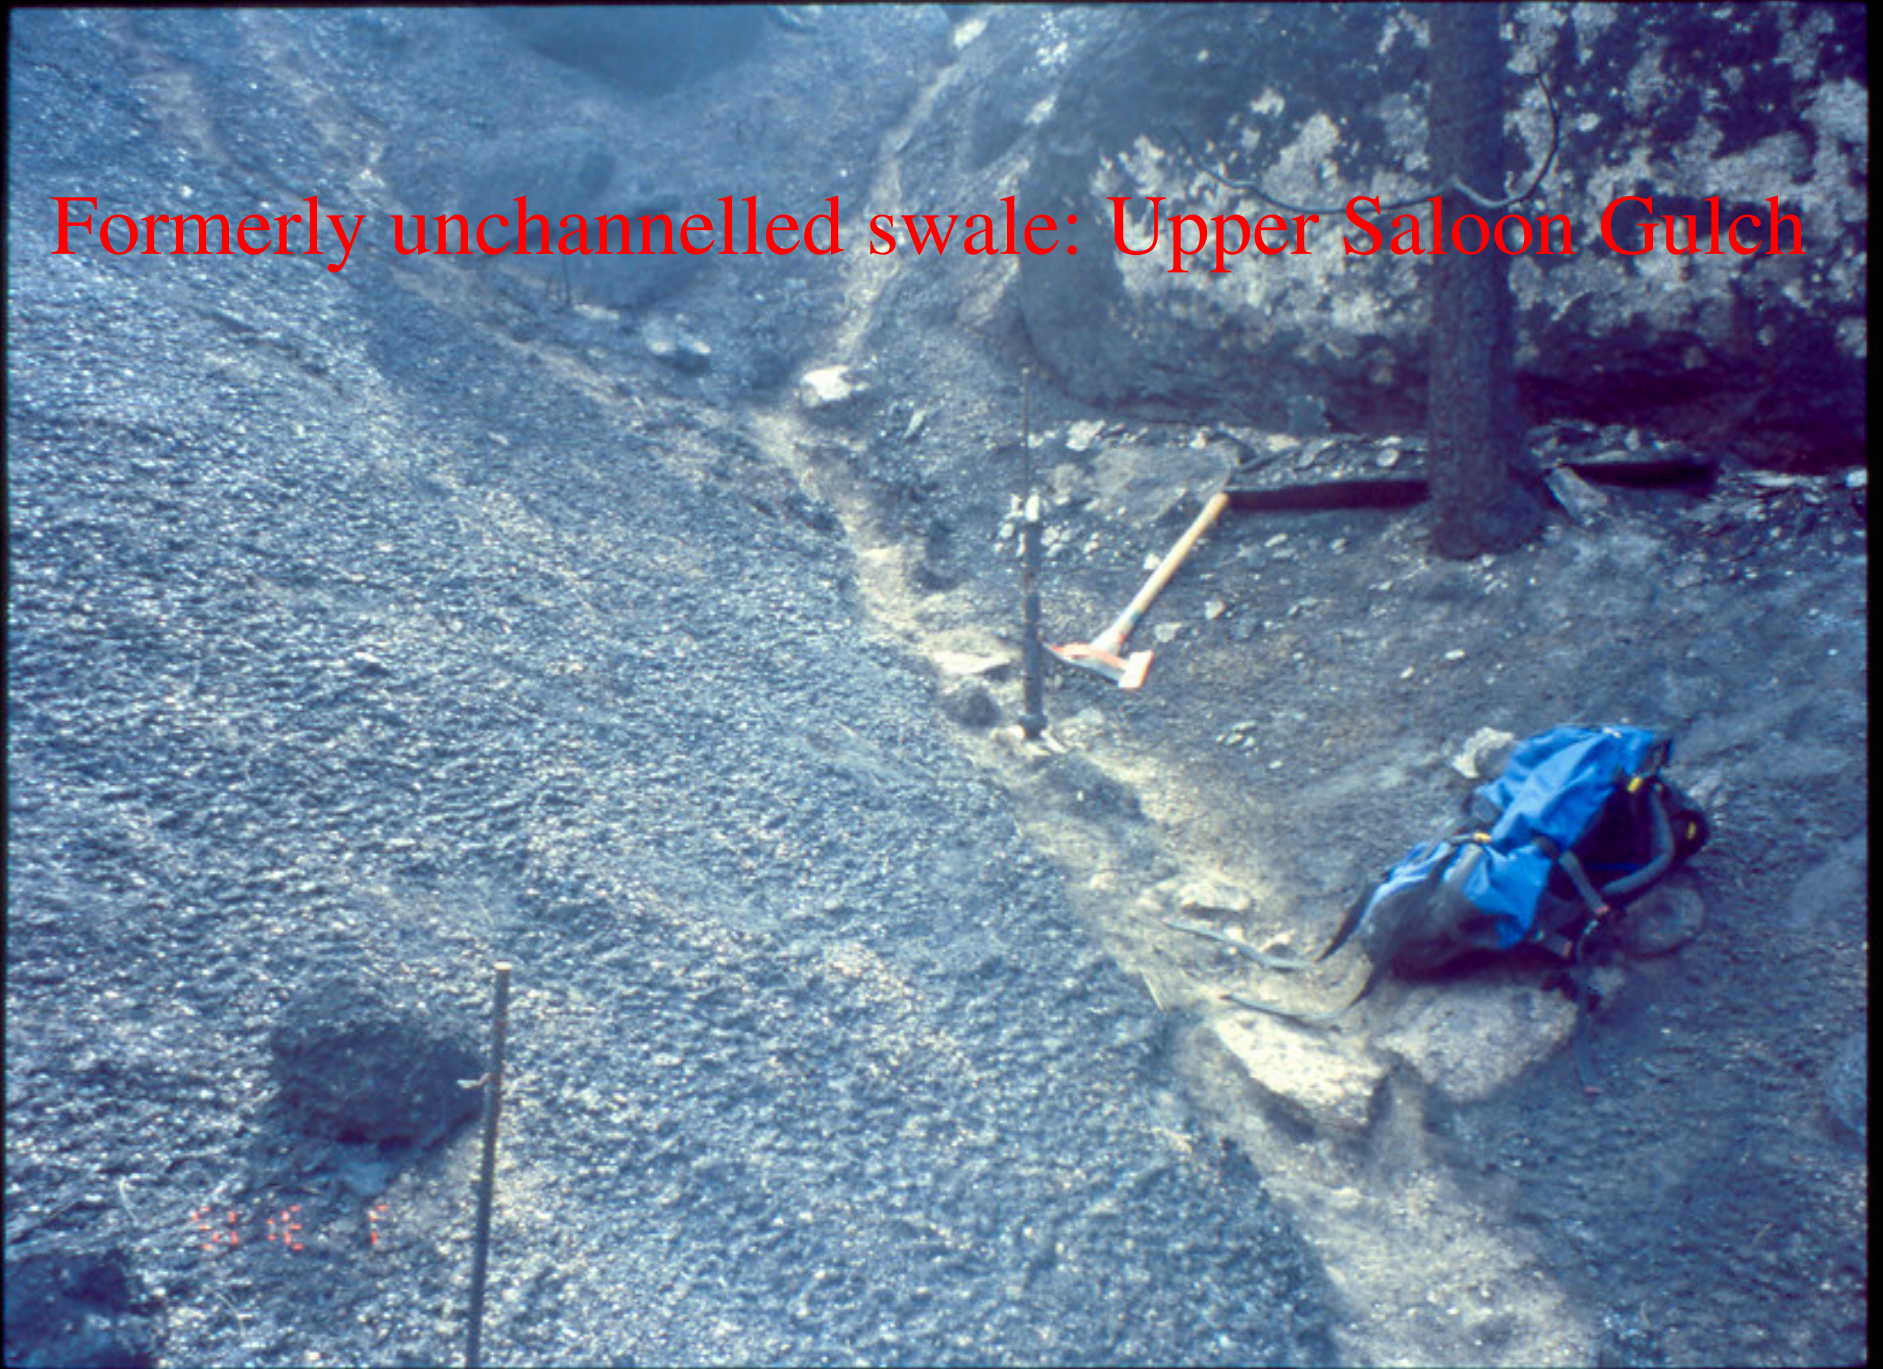
Formerly unchannelled swale: Upper Saloon Gulch

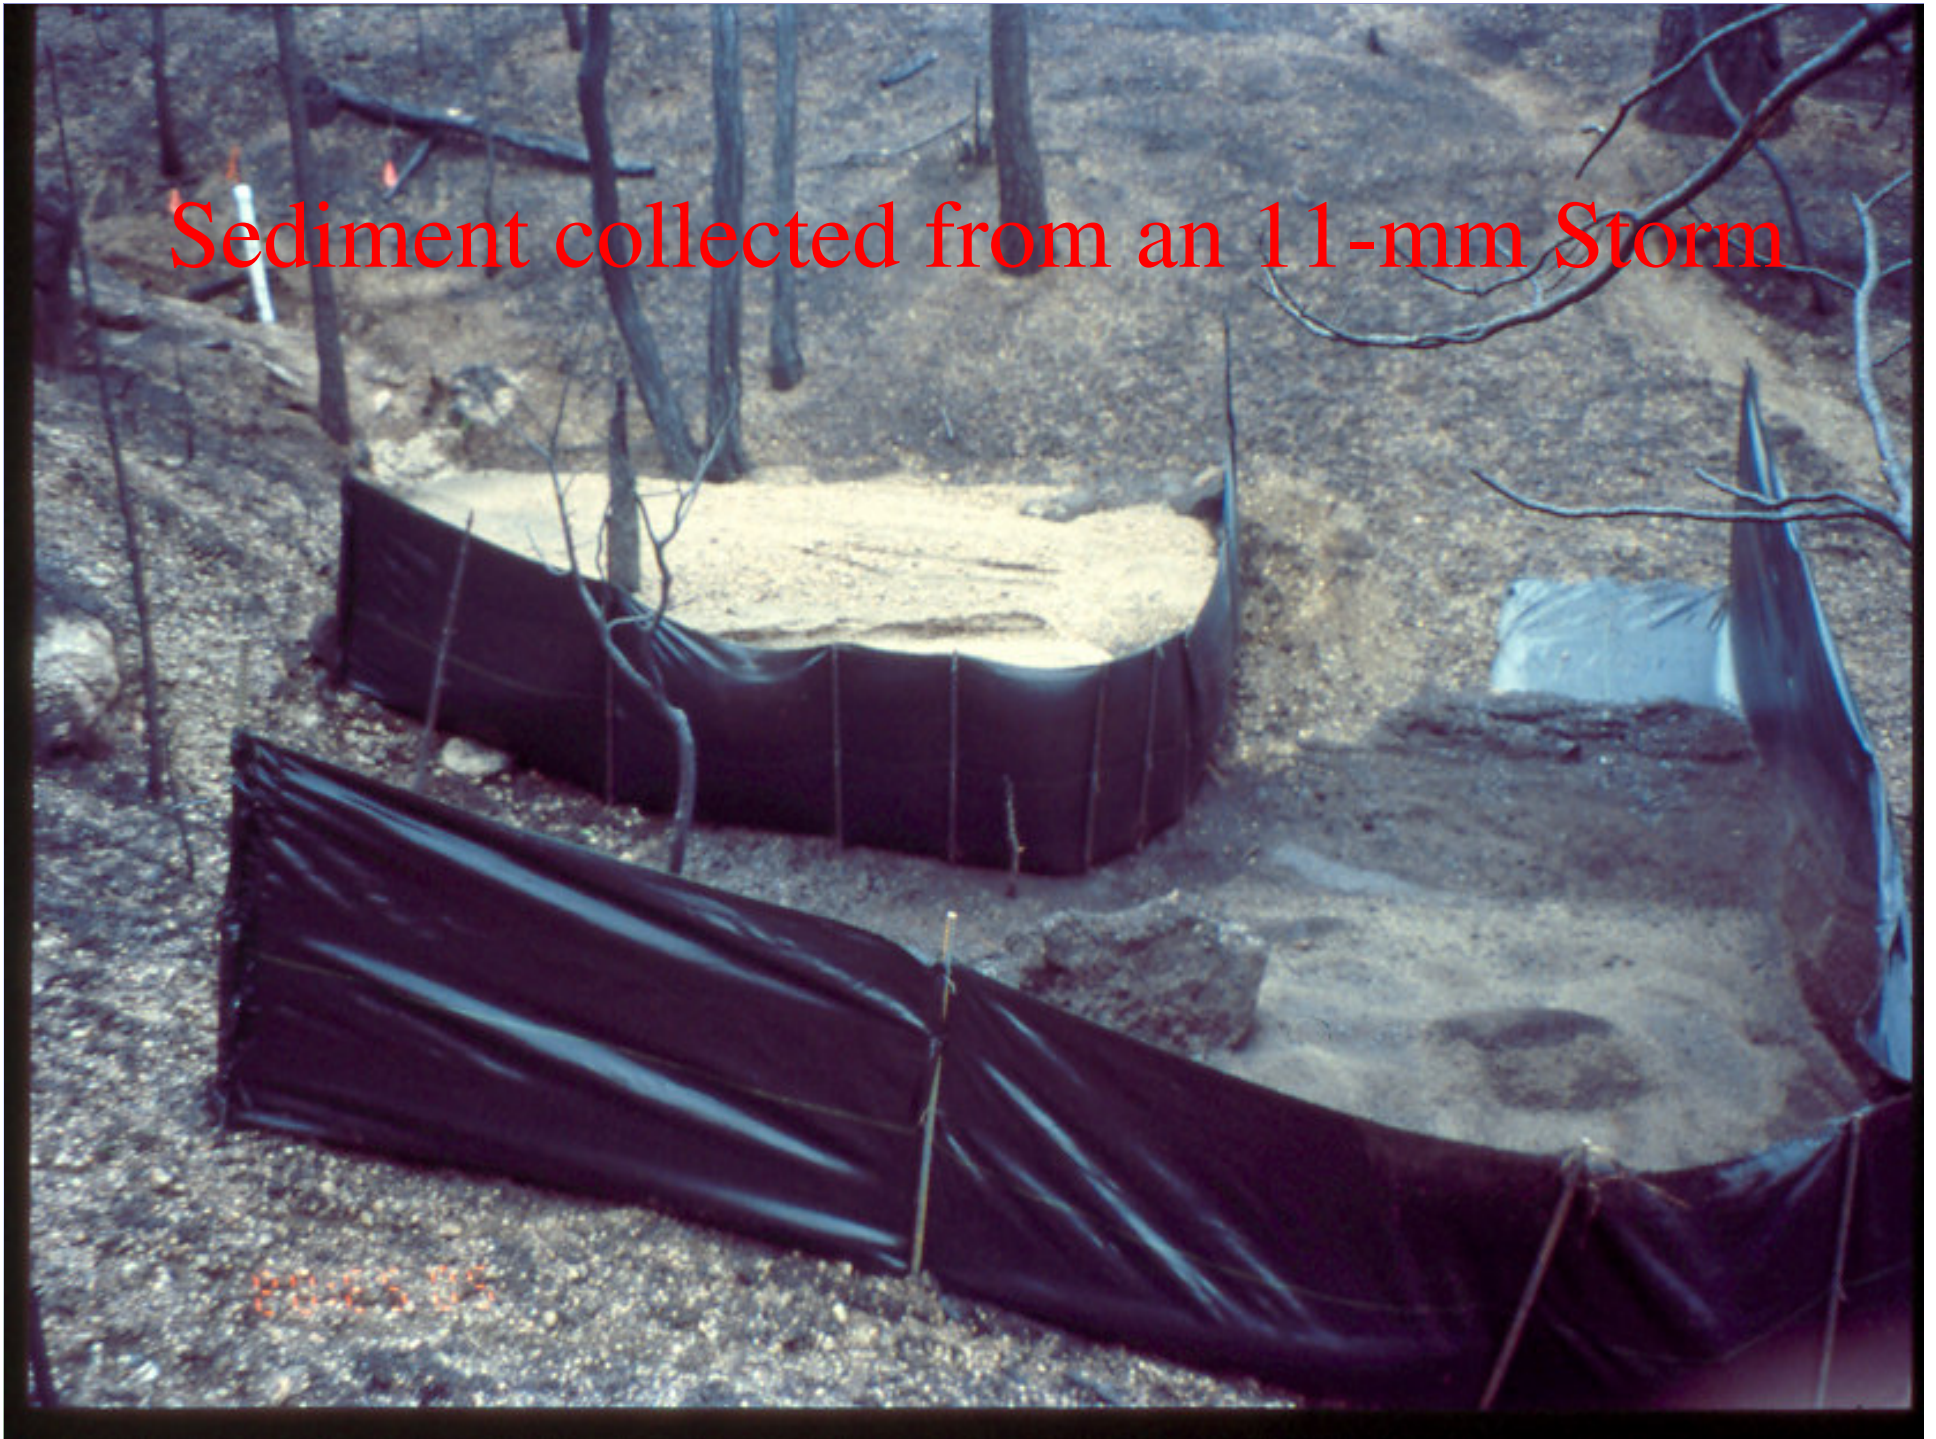
Sediment collected from an 11-mm Storm

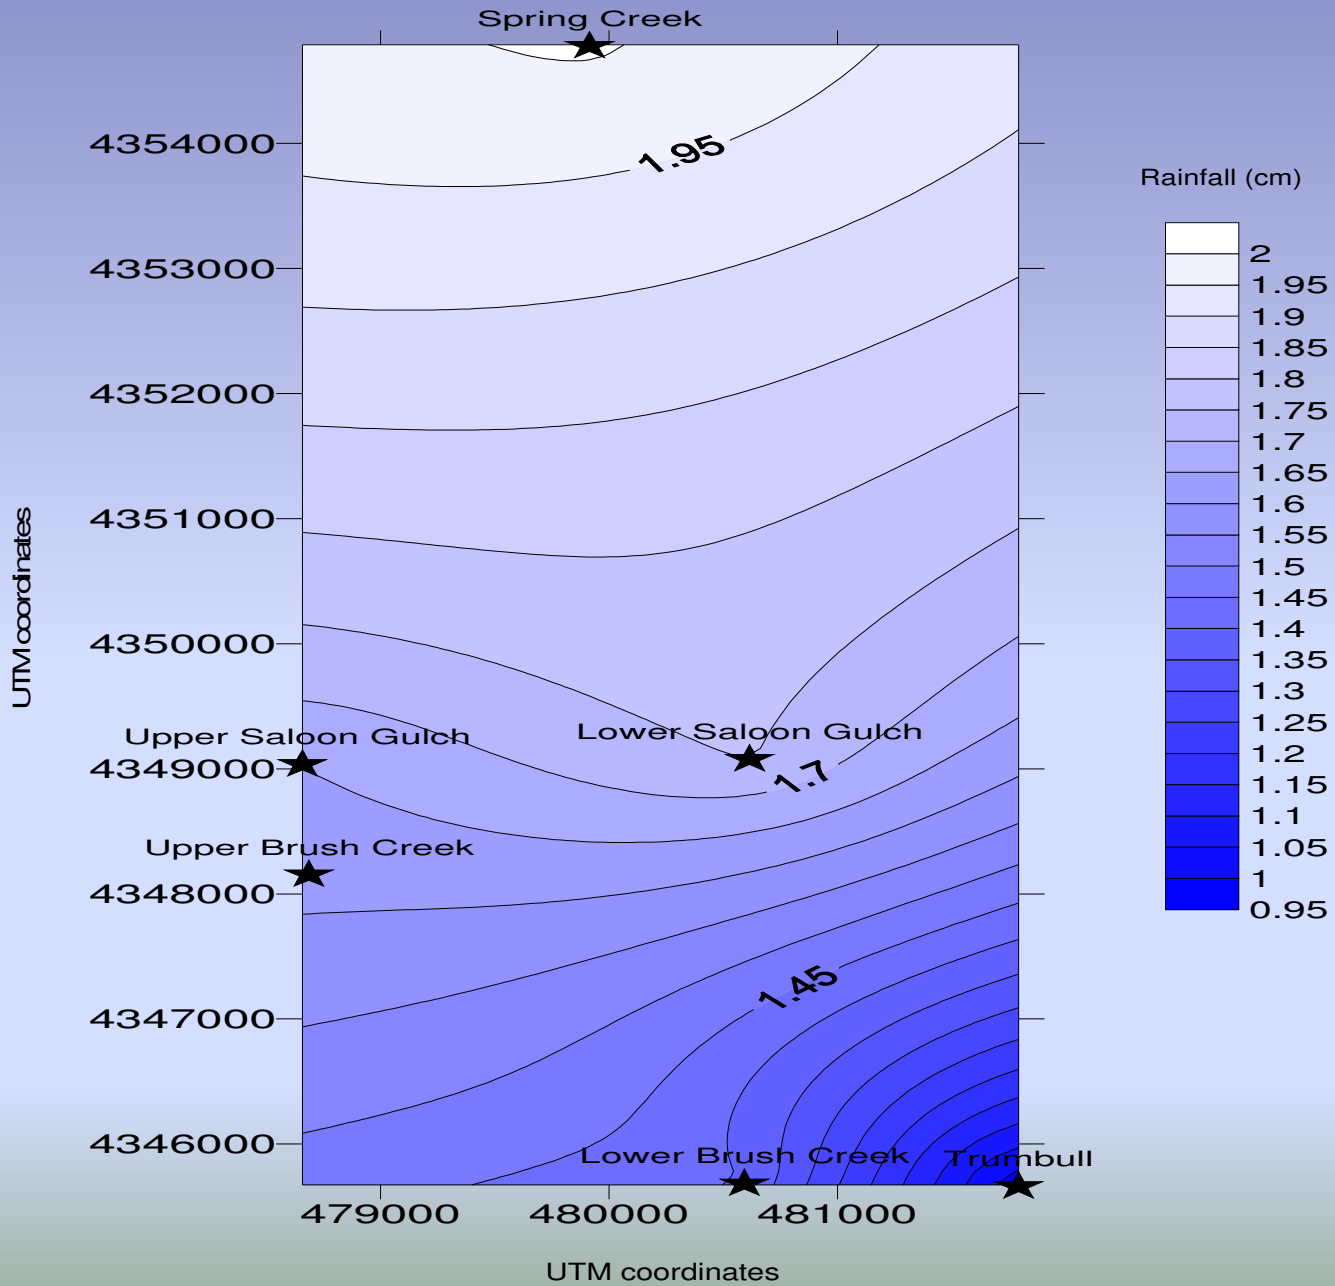
Rainfall for storm on 06 July 2002

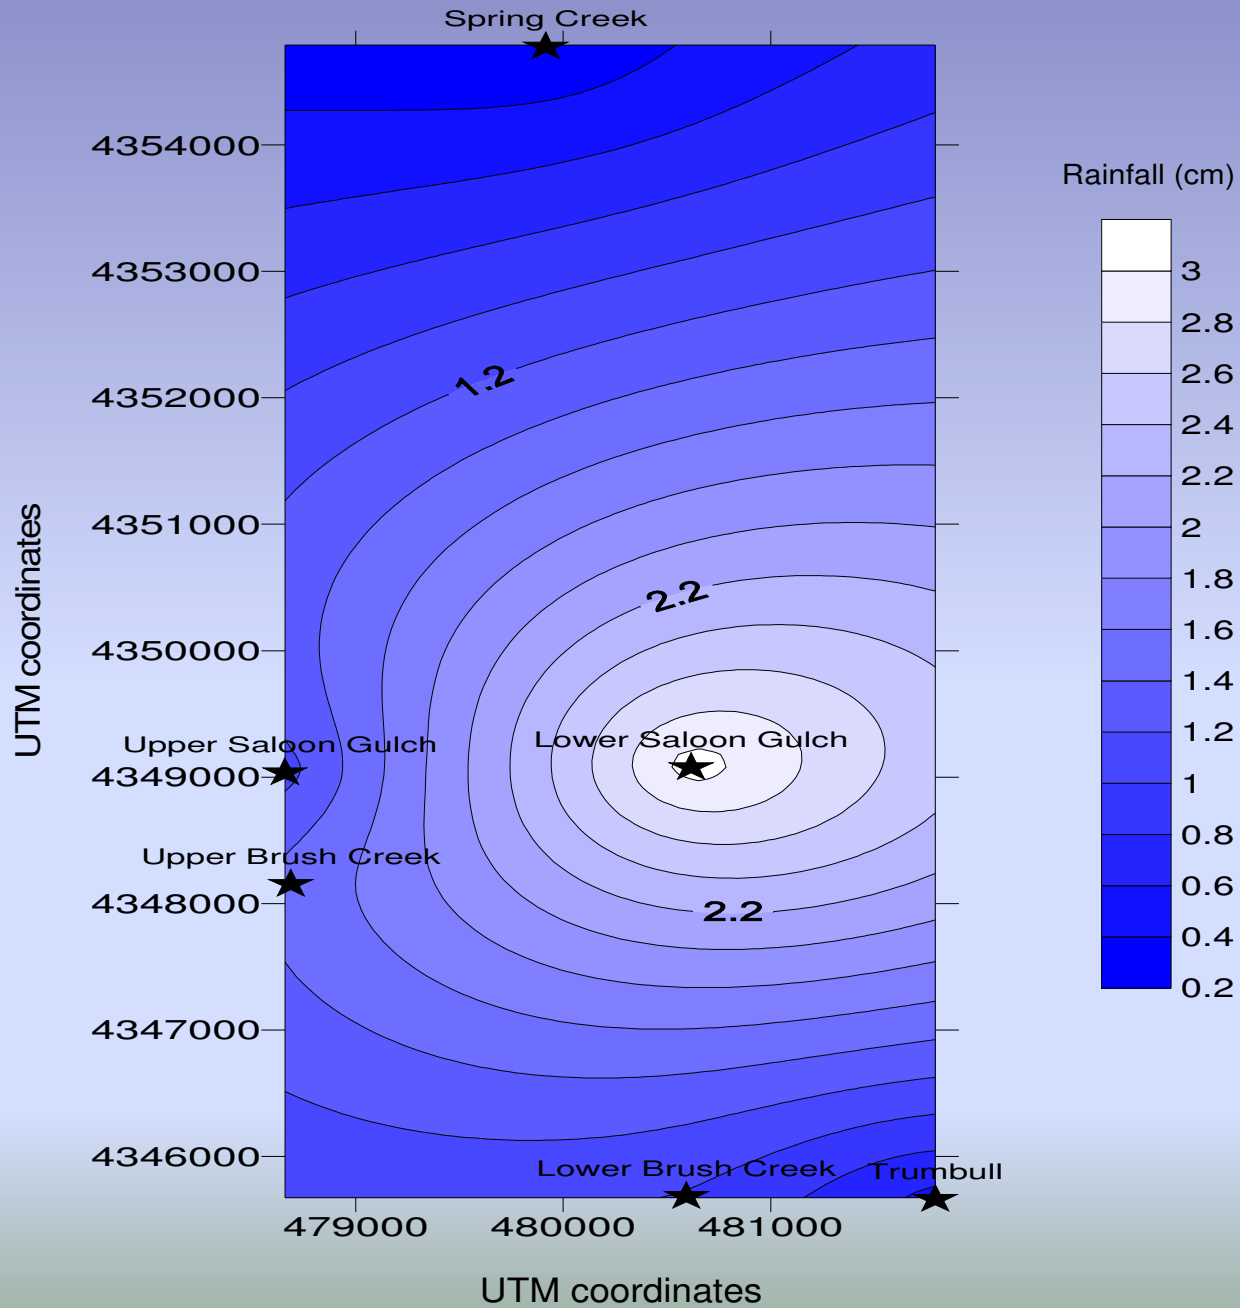
Rainfall for storm on 21 July 2002

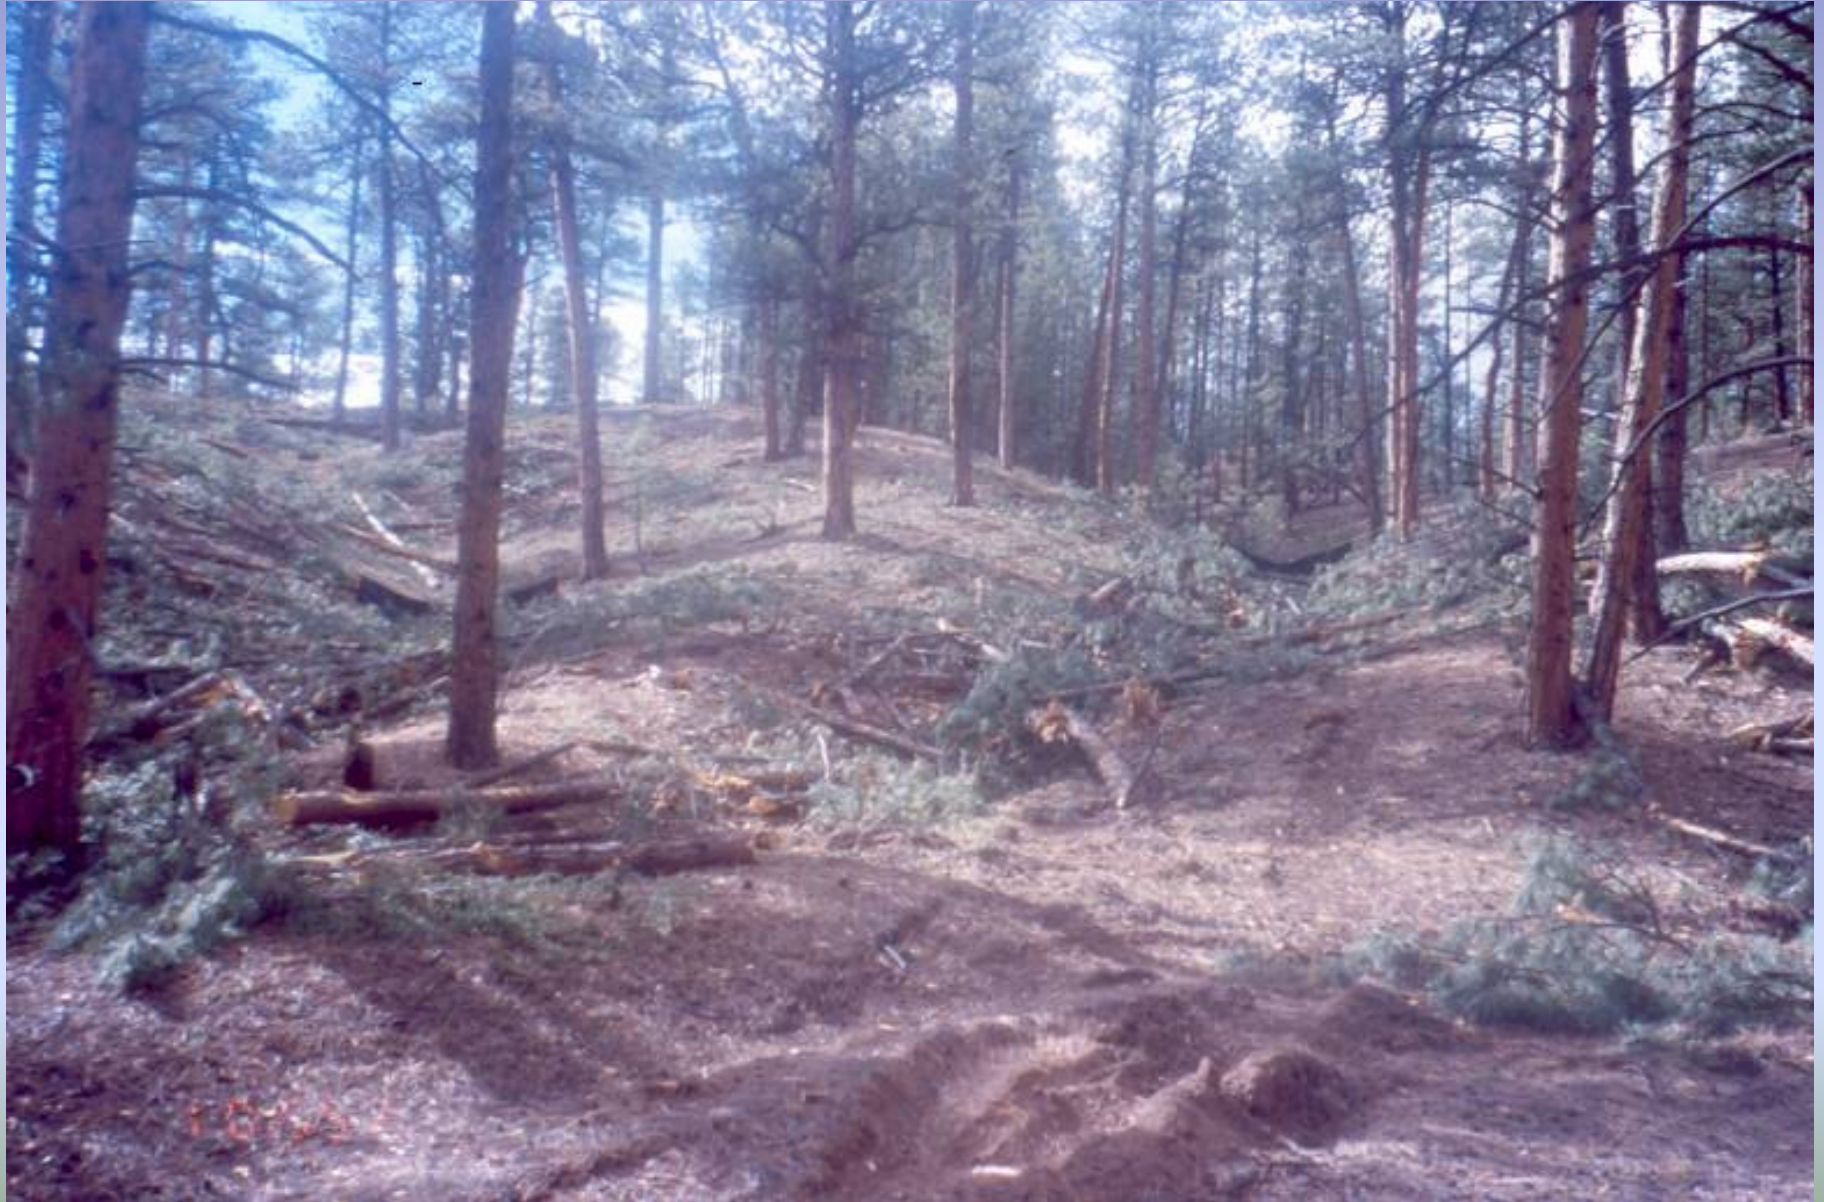
Swale in Trumbull after Thinning

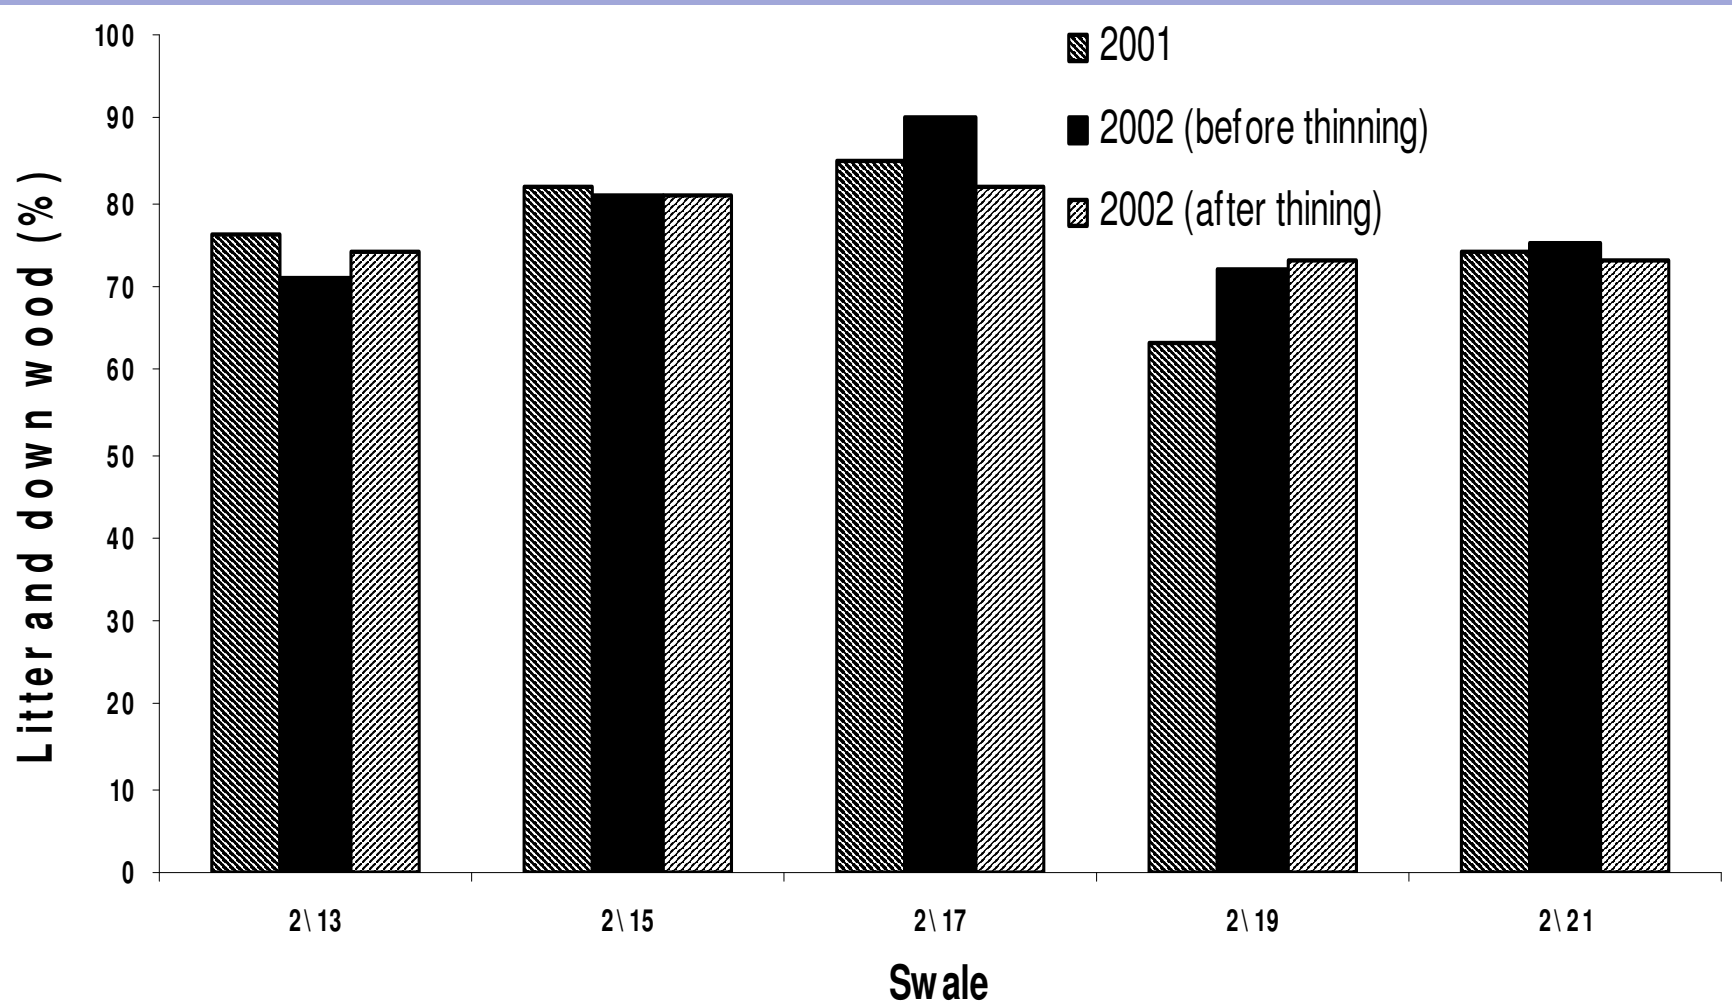
Percent litter and downed wood before and after thinning

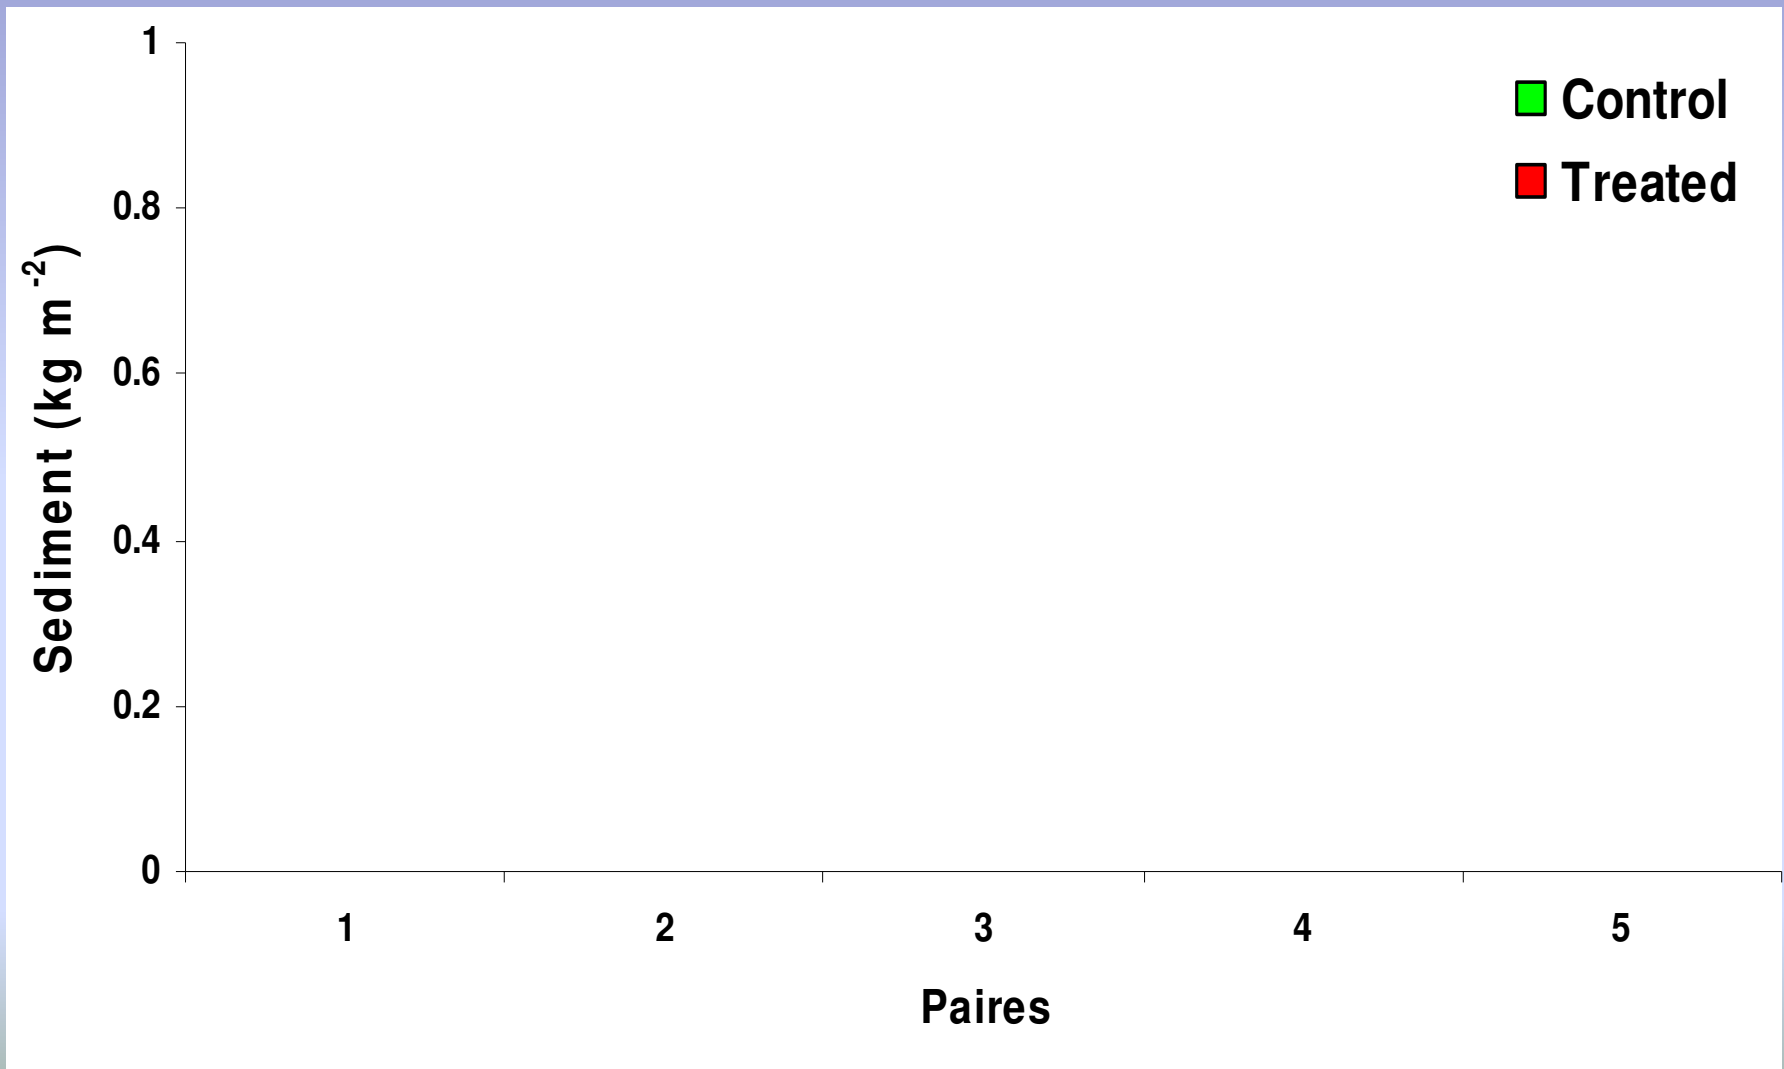
Sediment production from paired swales in Trumbull: 2003

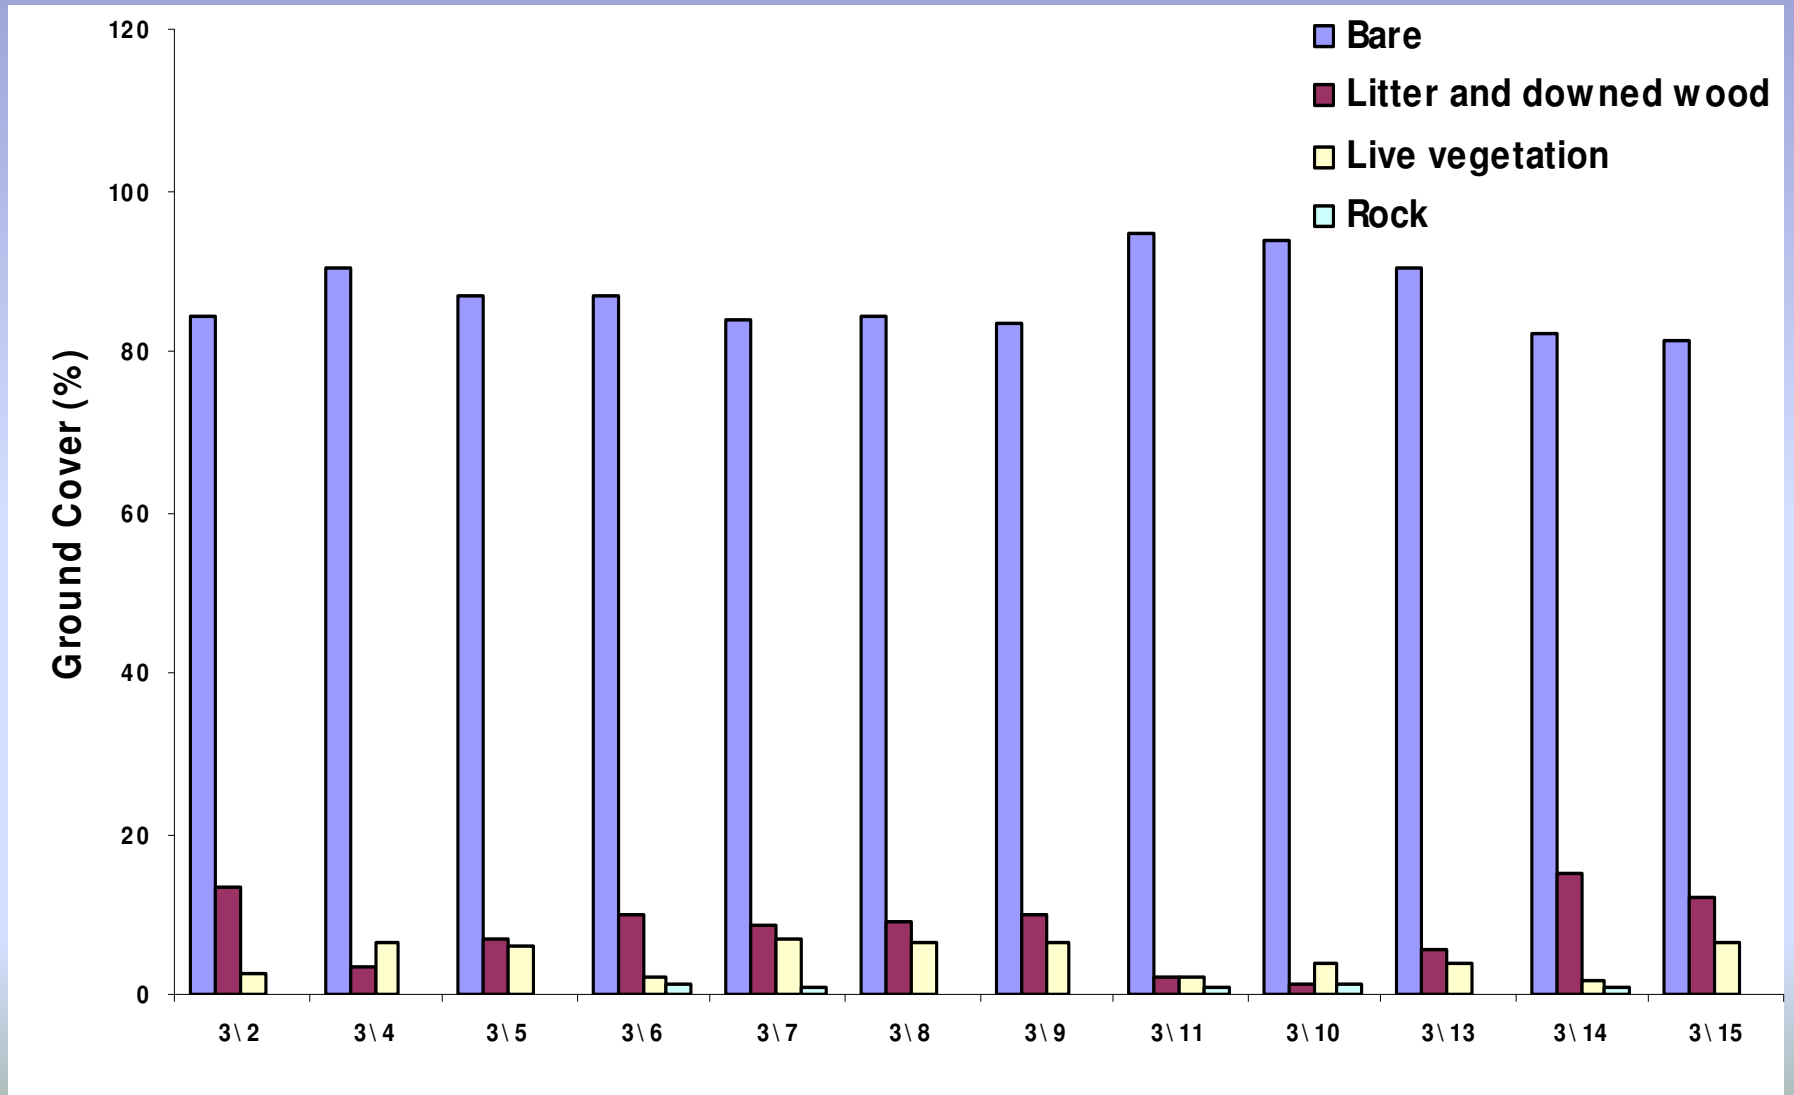
Percent cover on road segments: Spring Creek 2003
