USPPRP Monitoring:
Results from 2003 and Plans for 2004

L.H. MacDonald, E. Brown, and Z. Libohova
Dept. of Forest, Rangeland, and Watershed Stewardship
Colorado State University

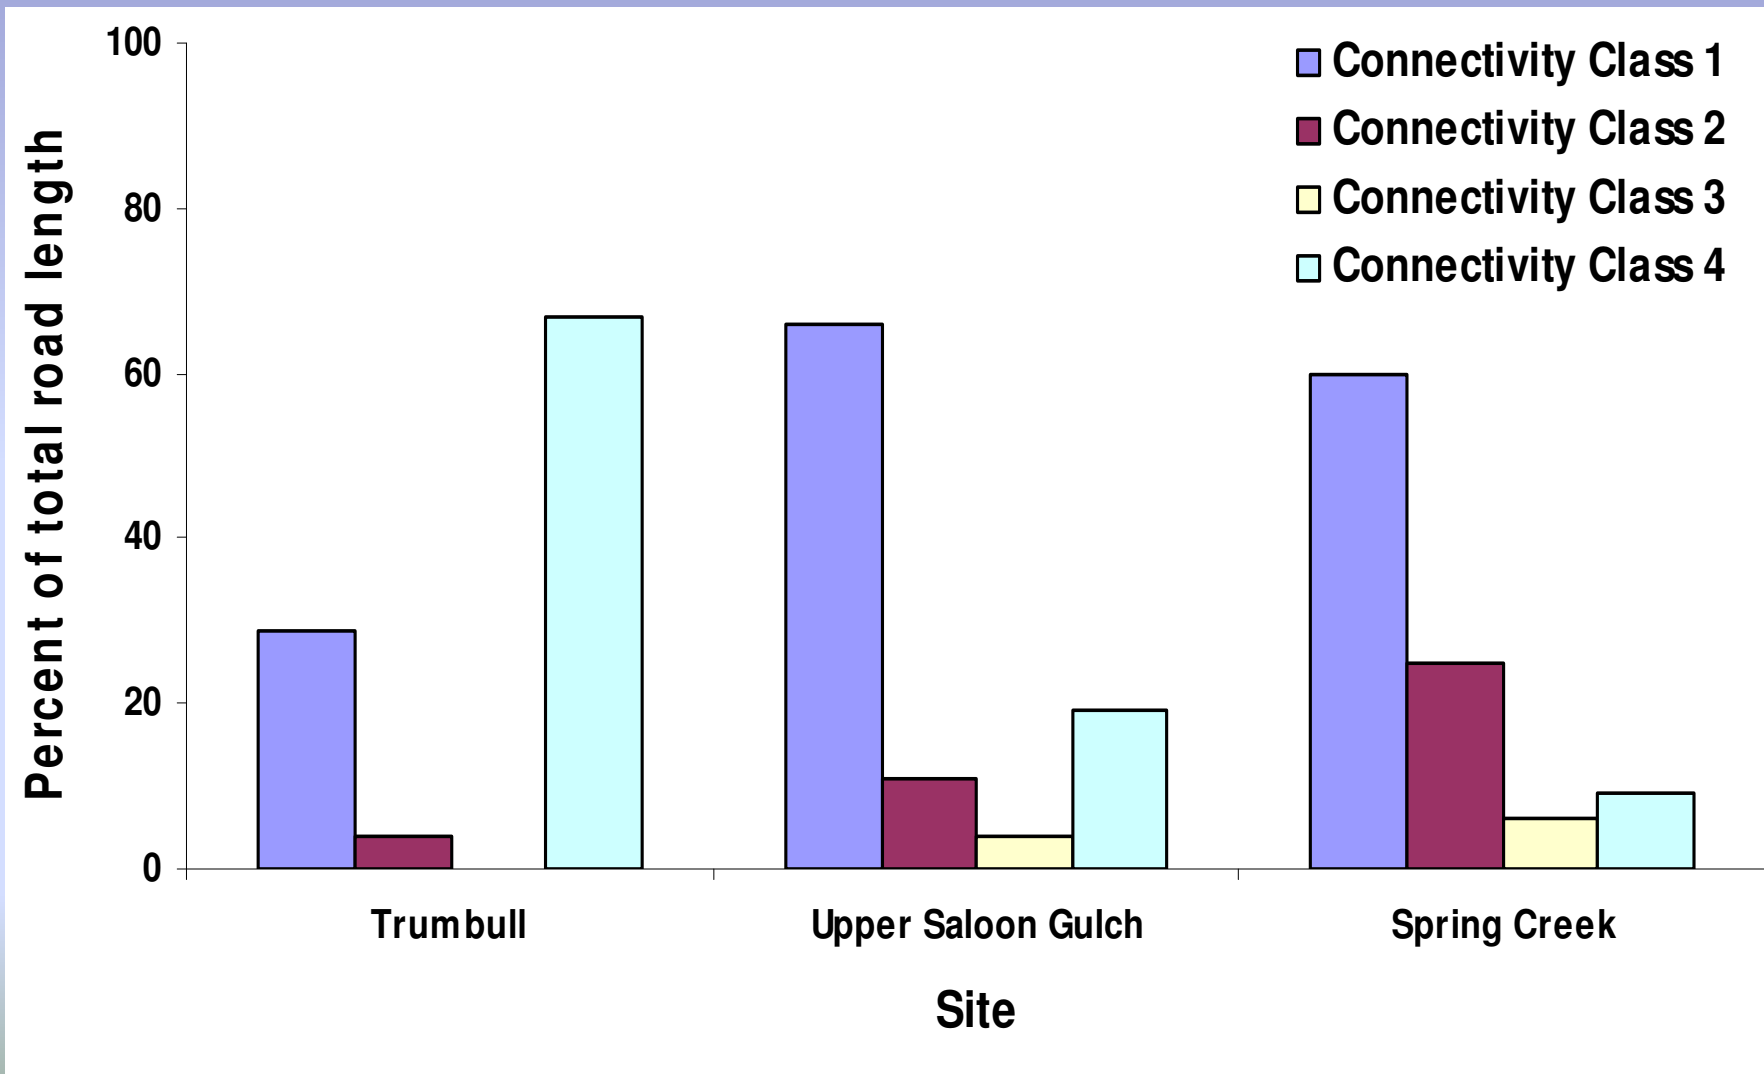
Road connectivity in three study sites

- (1) No sign of concentrated flow below the drainage outlet;
- (2) Concentrated flow present but extends for less than 20 m;
- (3) Concentrated flow extends for more than 20 m but stops more than 10 m from the edge of a stream;
- (4) A continuous rill or sediment plume to a stream channel.
