THESIS

POST-FIRE CHANNEL CHANGE IN TWO SMALL WATERSHEDS IN THE
COLORADO FRONT RANGE

Duncan T. Eccleston

Colorado State University

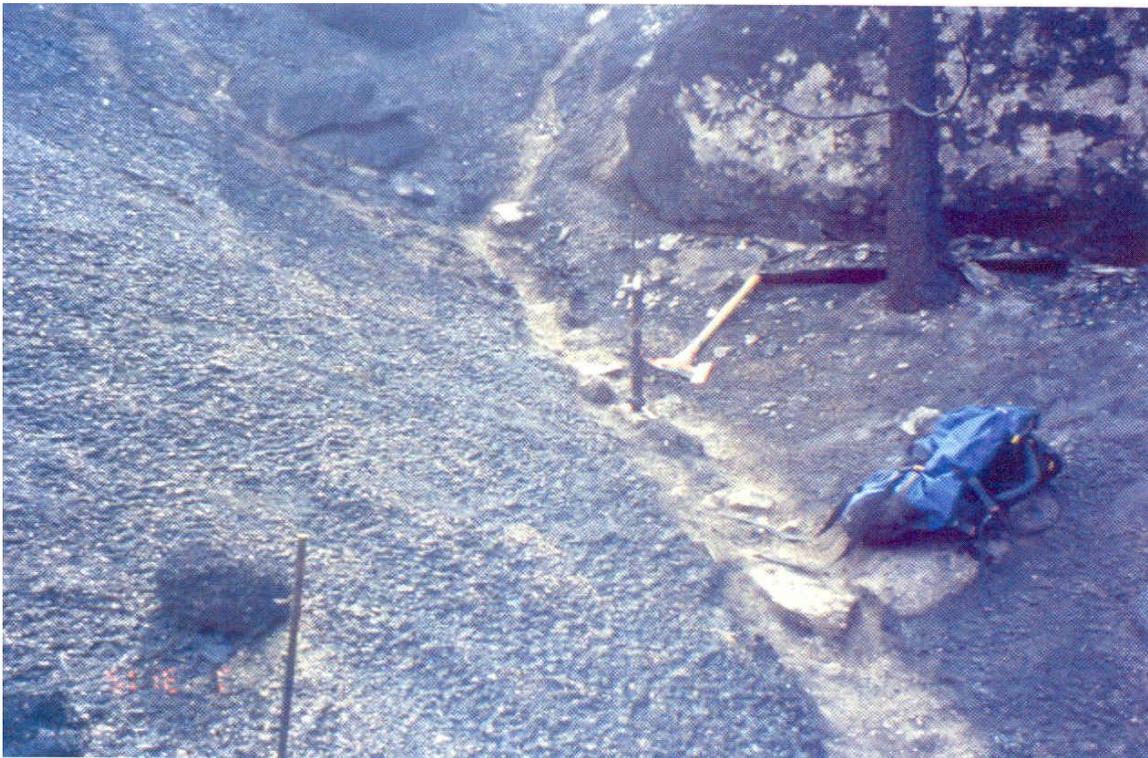
Figure 3. Rills developed in the swale axes as a result of the first rainstorms after the Hayman Fire.

After the fire, rilling was initiated on most planar hillslopes and where flow is concentrated by convergent topography (Figure 3). Rills become wider and deeper moving downstream, and generally become gullies where the contributing area is about 0.5–1 ha (Figure 4). The gullies drain into flatter aggrading ephemeral channels. In Upper Saloon Gulch these channels are typically 2–8 m wide with low, eroding banks that suggest recent widening (Figure 5). The bed surface is generally planar in cross-section and longitudinally. In the upper watershed the ephemeral channels are confined by steep valley walls.

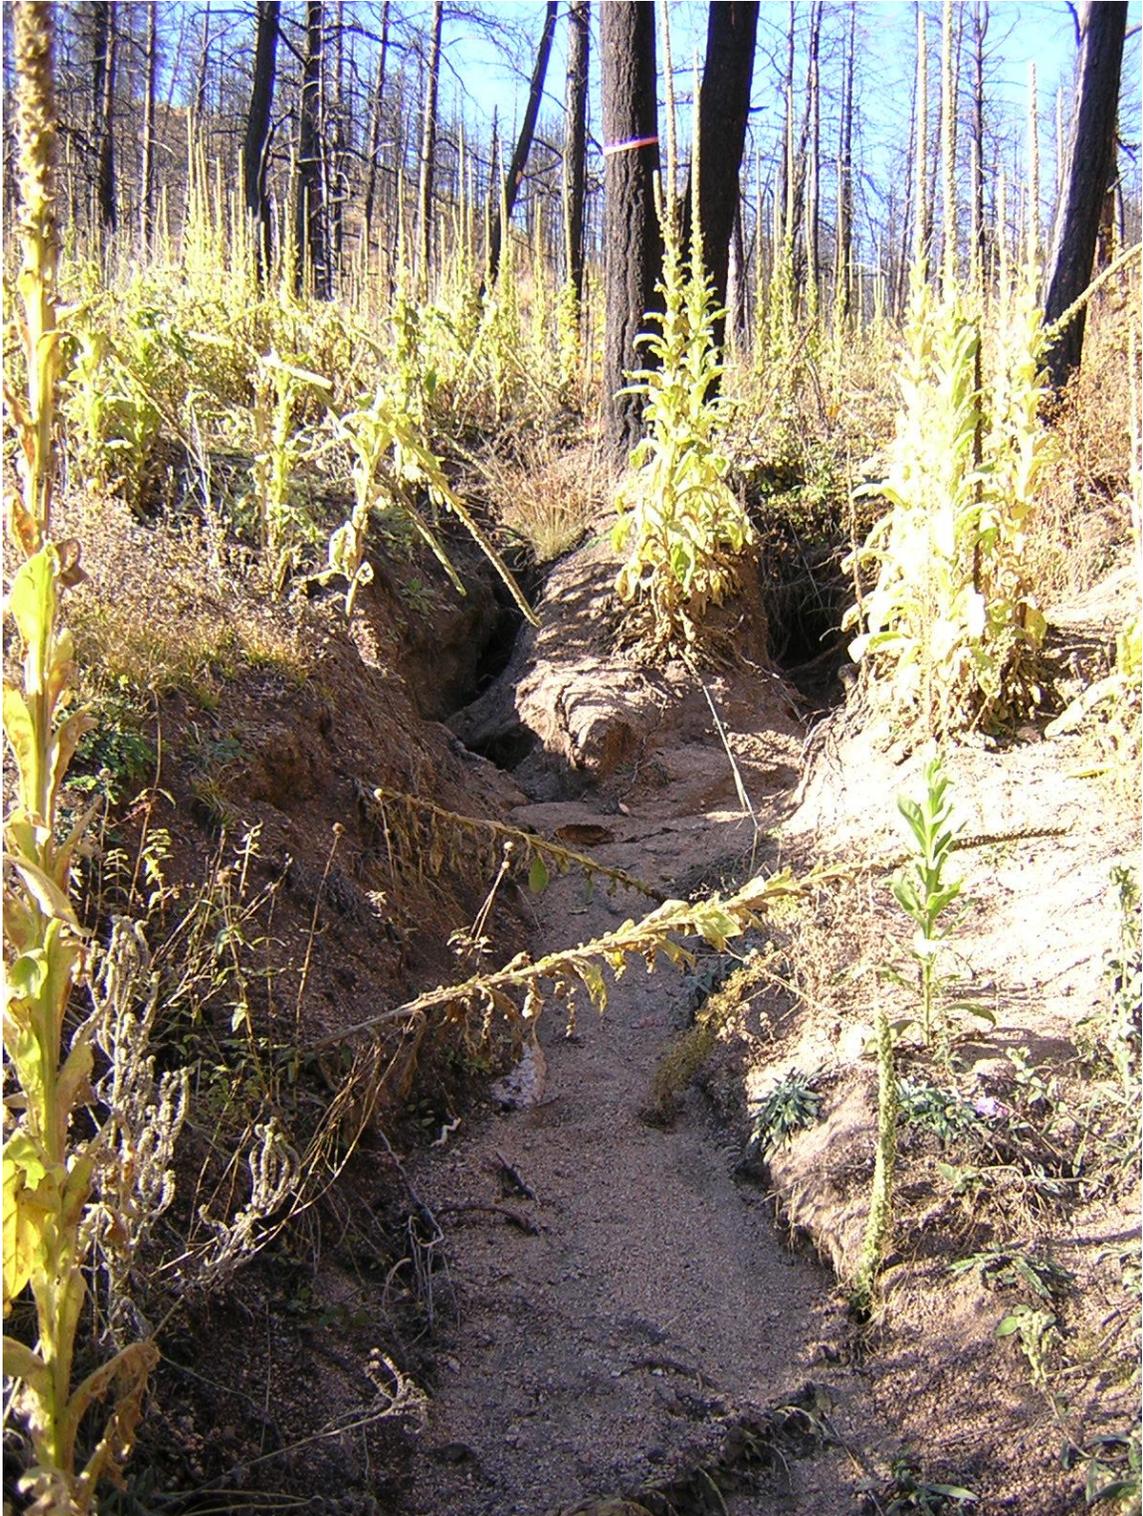
Figure 4. Deep gully in Brush Creek in summer 2004. The slope is about 17% and the contributing area is about 10 ha.

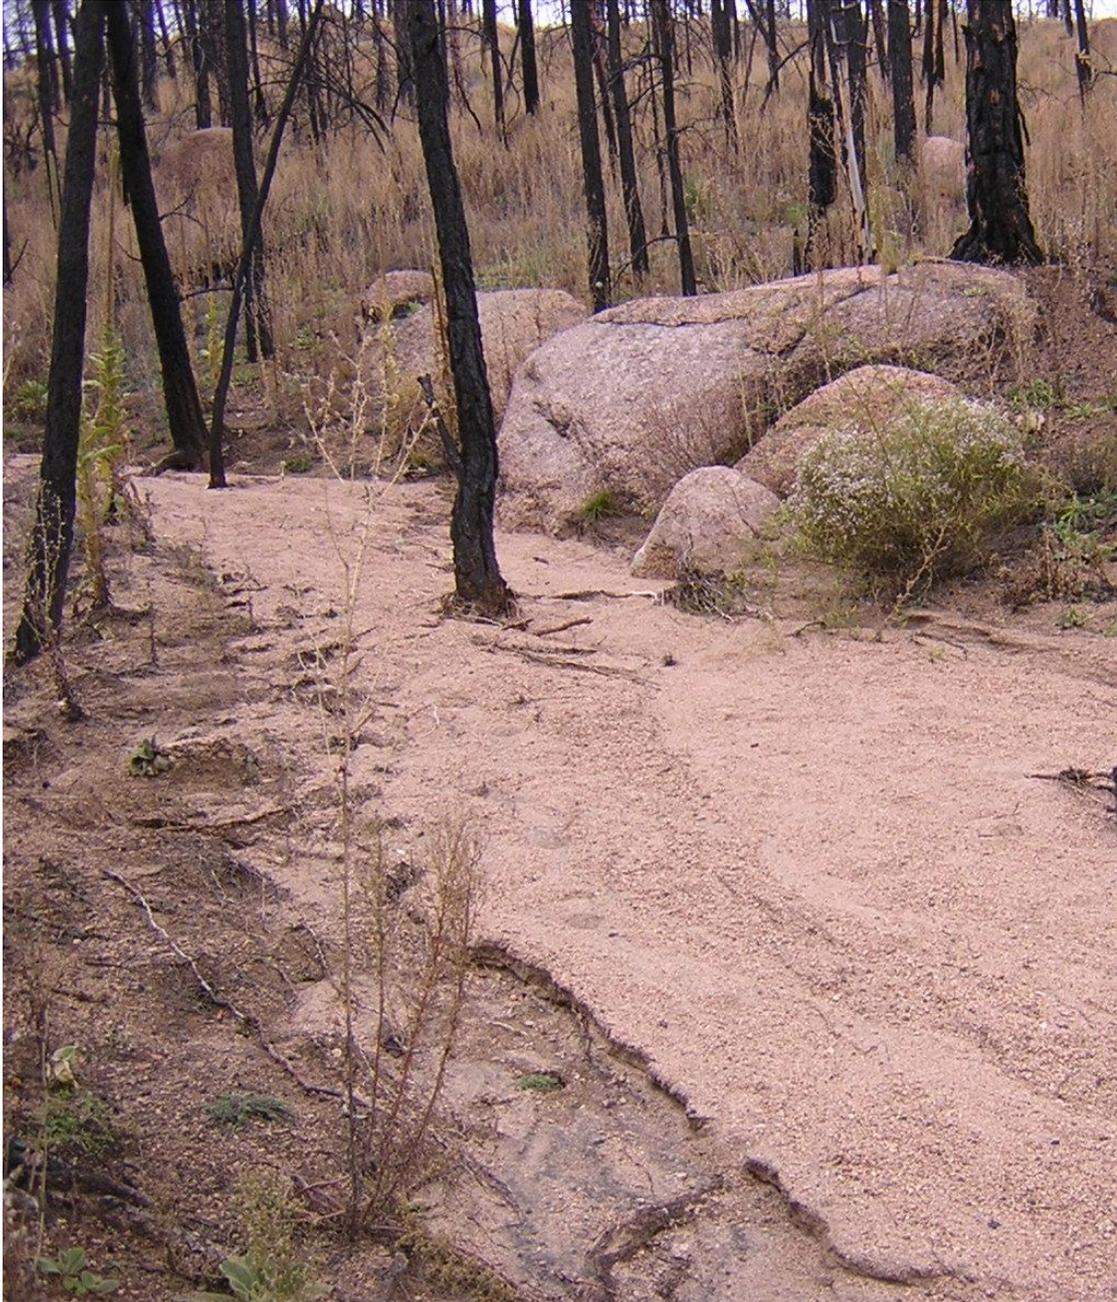
Figure 5. A moderately confined ephemeral channel reach in Upper Saloon Gulch in summer 2004. The slope is about 9% and the contributing area is about 0.25 km².

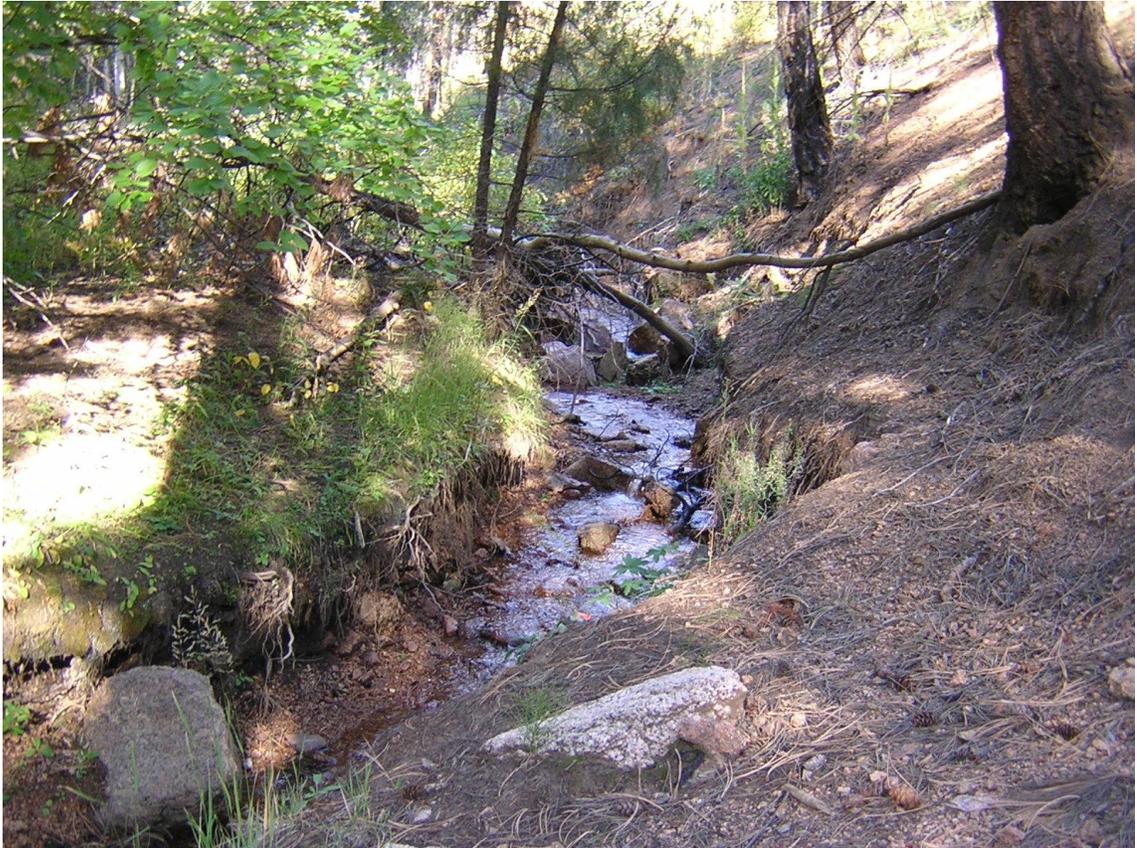
Figure 6. Typical confined perennial channel reach in Lower Brush Creek in summer 2004. The slope is about 6% and the contributing area is about 5.9 km².

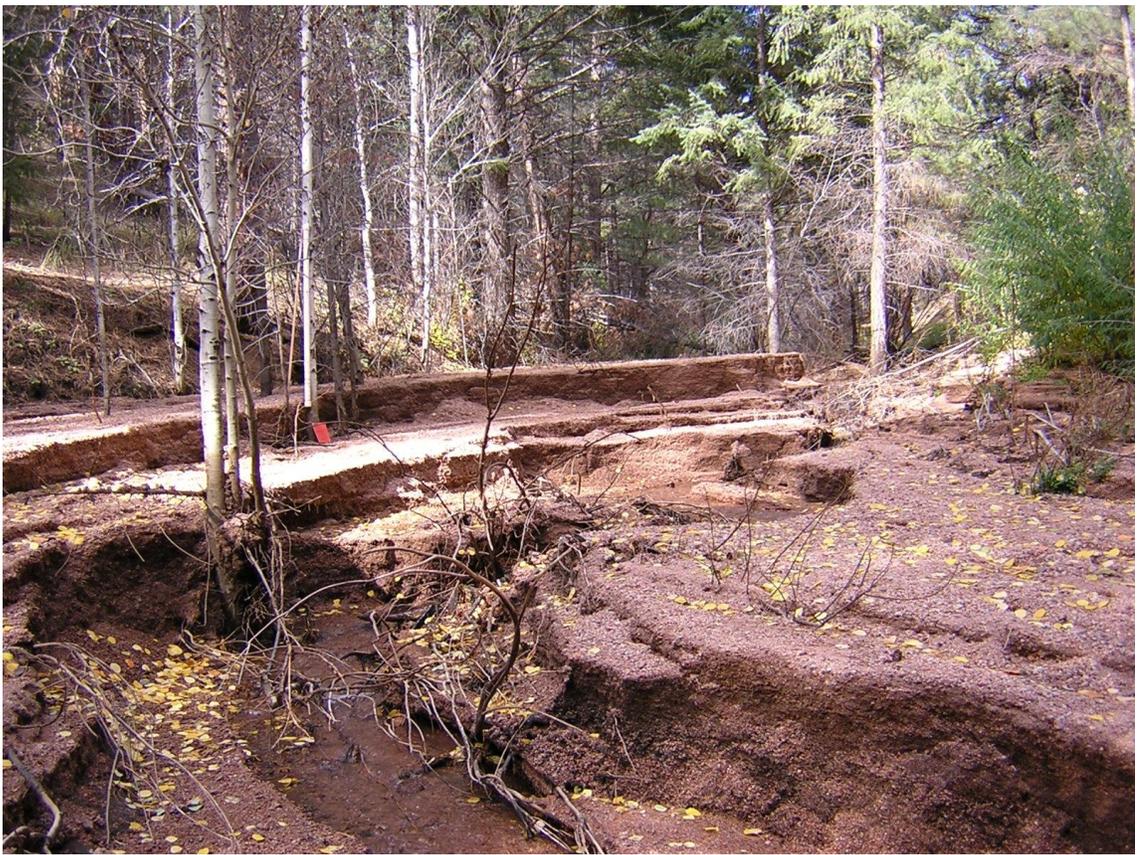
Figure 7. Study reach C_P3.3 in summer 2004. This is one of several reaches in Lower Brush Creek with extensive post-fire aggradation.

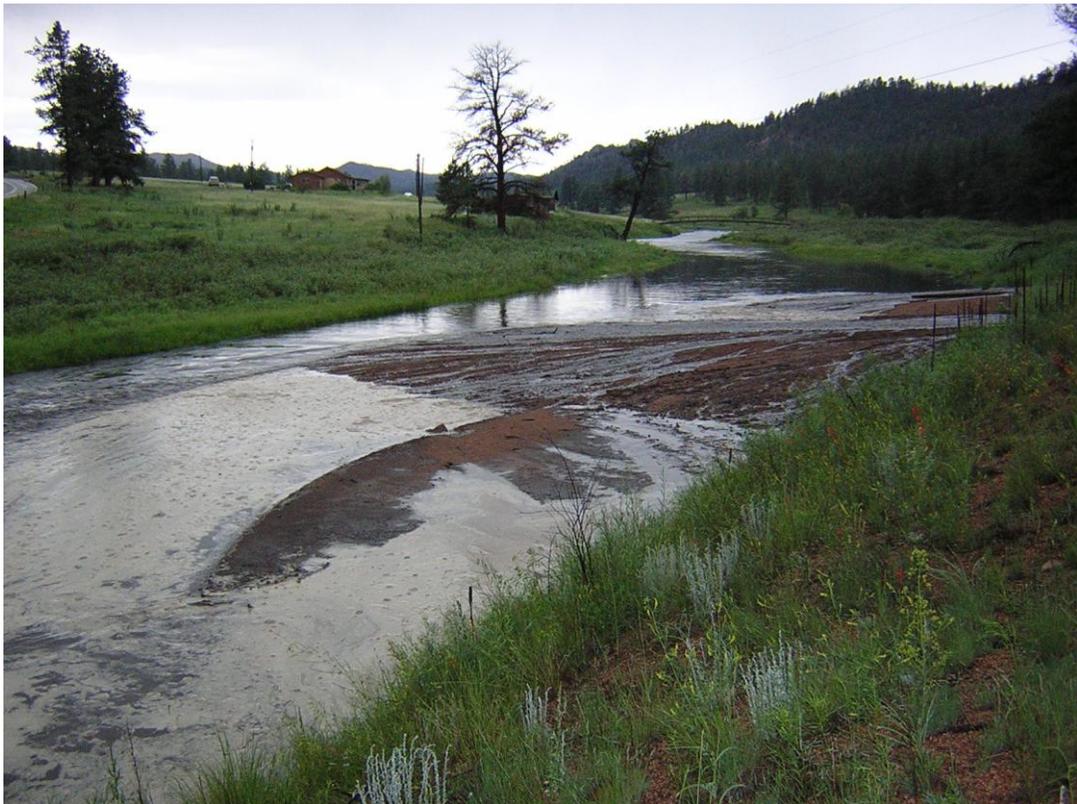
Figure 16. Alluvial fan formed by the flood on 14 July 2004 in Saloon Gulch. This fan extended across most of the South Platte River, but most of the material was eroded away within 2-3 days, leaving a 1-2 m knickpoint.

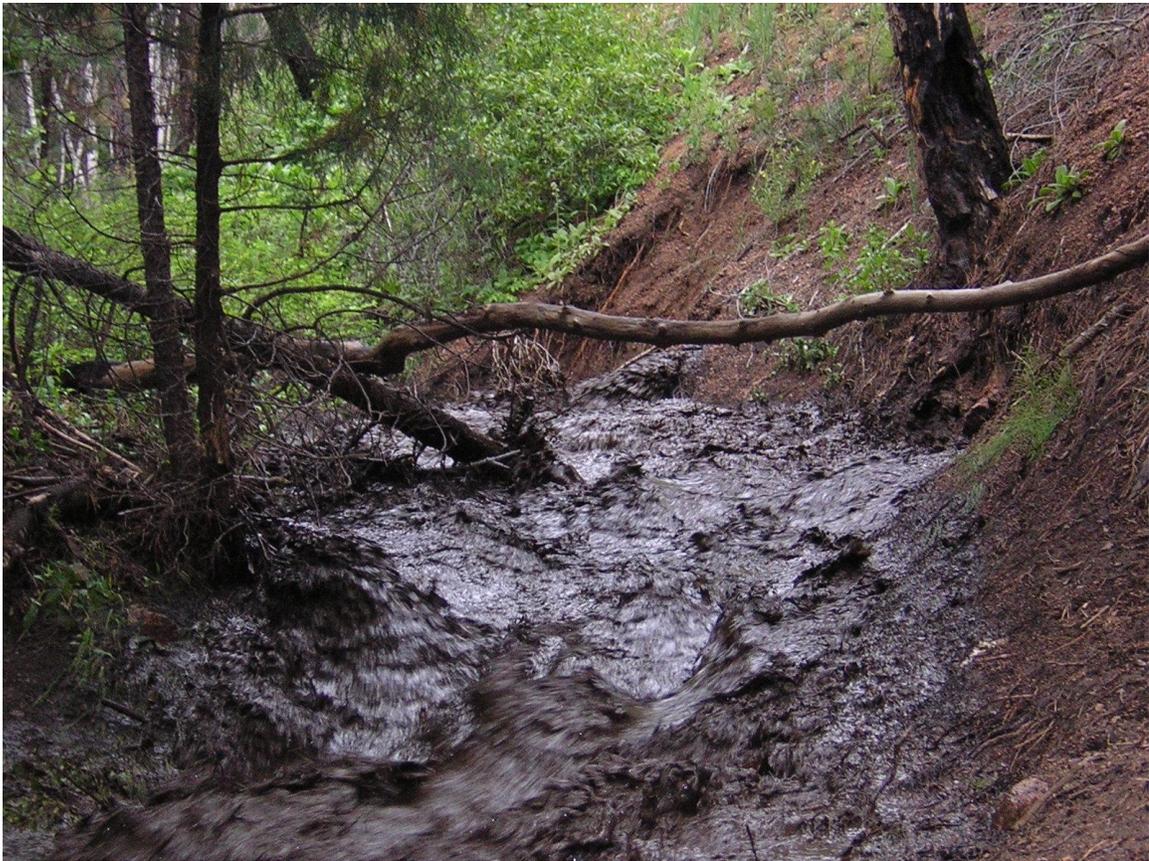
Figure 17. Turbulent flood flows in Lower Brush Creek on 29 June 2004.

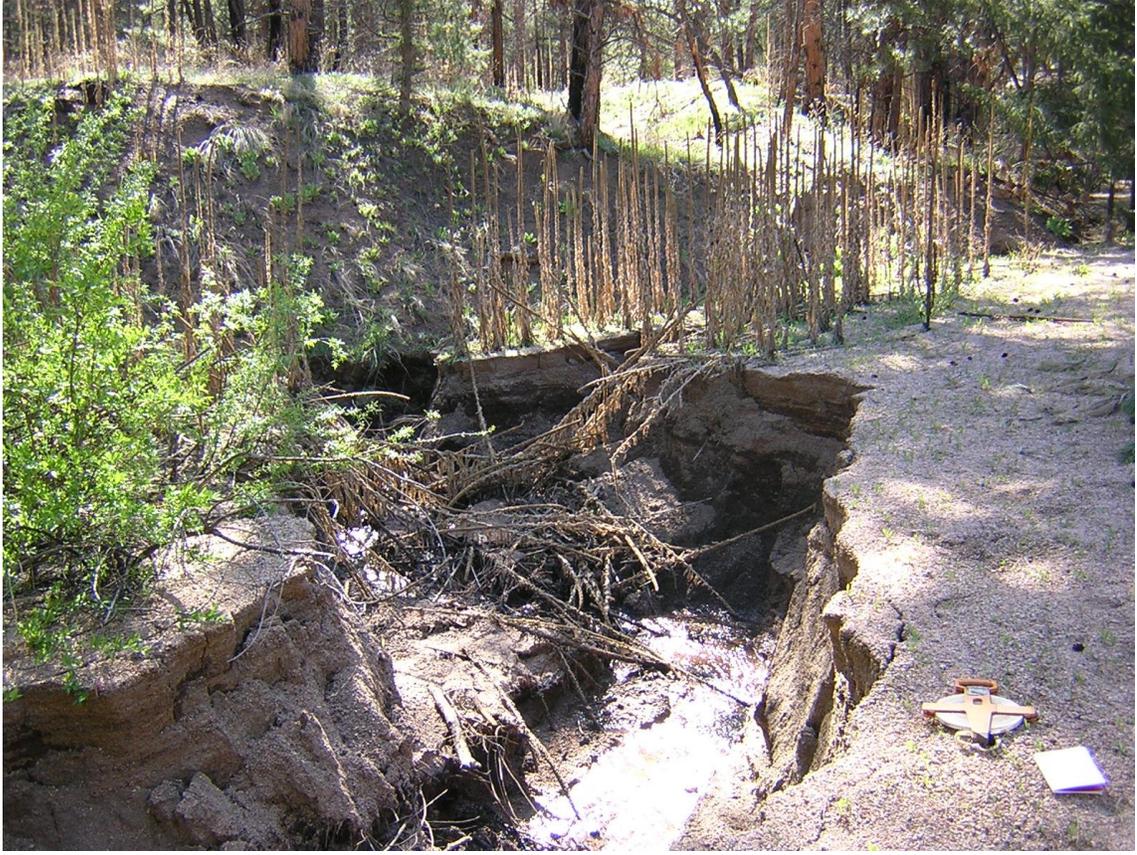
Figure 19. Snowmelt runoff incised a deep channel into post-fire deposits in reach C_E2.0, which was the narrowest reach in Lower Saloon Gulch. This incision caused a shift in the flow regime from ephemeral to perennial.
