## The Technical Newsletter of the National Stream and Aquatic Ecology Center

February 2017

### Resurrection Creek: A Large Scale Stream Restoration on the Kenai Peninsula of Alaska

## Fire Effects on Road Sediment Production and Delivery

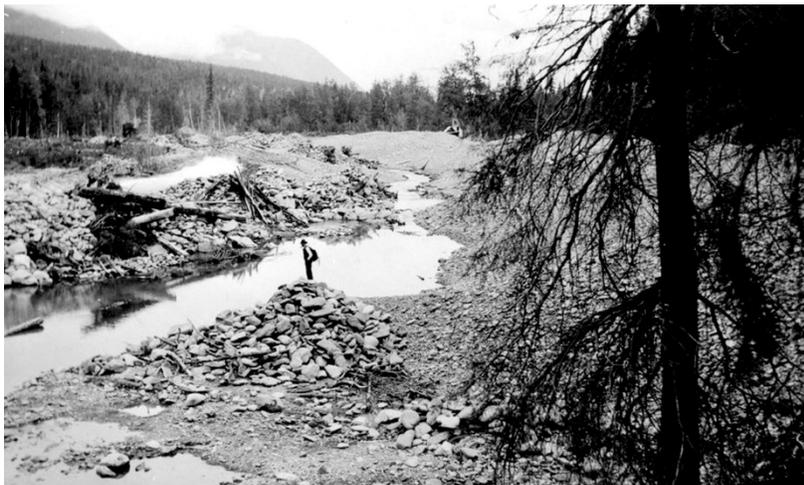
**Figure 1:** Hydraulic mining along a stream corridor in Alaska (photo courtesy of Alaska State Library).

impairing fish and wildlife habitat. The most severe impacts were from hydraulic placer mining (Figure 1) in the first two decades of the twentieth century. Tailing piles from hydraulic mining, some over 30 feet high, disconnected or buried the historic stream channel and wetland complexes (Figure 2A) that previously provided high-quality habitat for fish and wildlife. In 2002, Chugach National Forest and Enterprise Program personnel launched a large-scale effort to restore and reconnect the historic floodplain, stream channels, and riparian areas (Figure 2). From 2005 to 2007, 1.5 miles of Resurrection Creek were restored. The fish and wildlife response was immediate

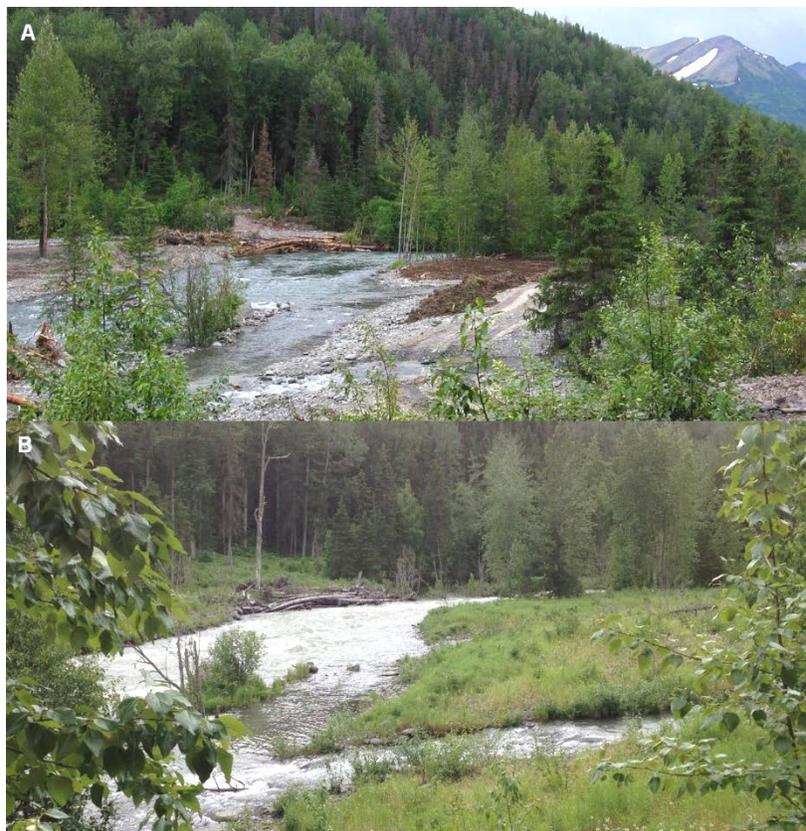
**Figure 4:** Restored channel, with large wood structures and added floodplain soil material, A) year of construction (7/6/2005) and B) seven years after construction (6/26/2012).

and erosion potential during floods. Approximately 500 pieces of large wood were placed into engineered log jams along the main channel (Figure 4). These jams reduced water velocity in the side sloughs, provided spawning and rearing cover and a nutrient supply for fish, and captured additional wood during flooding. Approximately 5,000 cubic yards of soil and woody material were spread onto the newly created floodplains (Figure 4A) to enhance natural revegetation and increase the success of future hand planting.

Twenty engineered log jams (approximately 600 pieces of large wood) were constructed along the mainstem channel and within the new side channels. The log jams reduce water velocity in the side sloughs during flooding, provide spawning and rearing cover,

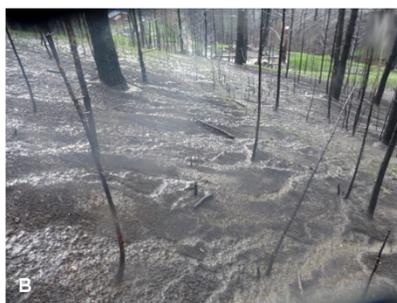
**Figure 5:** A) Overland flow and surface erosion immediately after a summer thunderstorm on a road segment in the Pike-San Isabel National Forest, Colorado. B) Overland flow on a hillslope recently burned at high severity west of Fort Collins, Colorado.

Similarly, high and moderate severity wildfires can increase surface runoff and erosion rates by two or more orders of magnitude at the hillslope scale (Figure 5B; Neary et al. 2005) with generally smaller increases at larger spatial scales (Wagenbrenner and Robichaud 2014). The increased surface runoff and loss of surface roughness after burning generally causes a large headward expansion of the channel network (Wohl, 2013) and a high lateral connectivity between the hillslopes and the channel network. The vegetative regrowth after a fire rapidly increases both infiltration and surface roughness, so these changes in runoff, erosion, stream density, and hillslope-stream connectivity typically persist for only about two years, or somewhat longer in areas with particularly poor growing

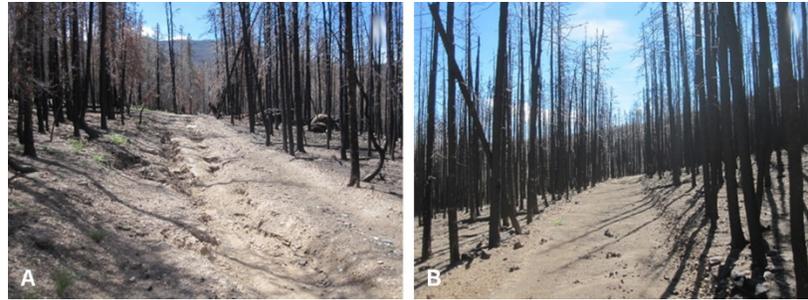
**Figure 6:** A) Road segment with 10% slope and surface rilling below an area that burned at high severity. B) Road segment with 2% slope below an area burned at high severity, with no rills due to deposited sediment.

A surprising result was that sediment tended to be deposited and accumulate on those road segments with a slope of 5% or less (Figure 6B). Road segments with slopes >5% never had more than 25% of their surface covered with sediment deposits.

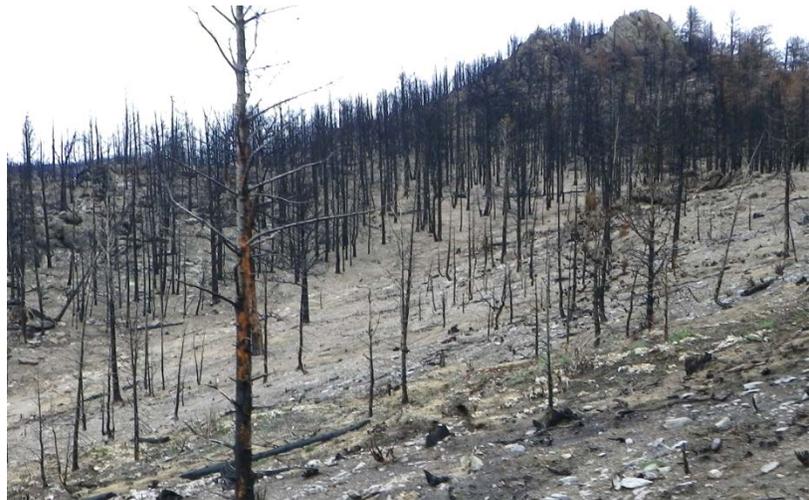
High and moderate soil burn severity hillslope adjacent to Old Flowers Road, 5/15/2013 (photo by Steven Yochum).
